Subject: Preliminary Slope Hazard Evaluation
Vacant Residential Lot
Corner of SW Walters Dr and SW Lovhar Drive
Gresham, Oregon

**VACANT TAX LOT
SW LOVHAR DRIVE
GRESHAM, OR**

Job #23-907

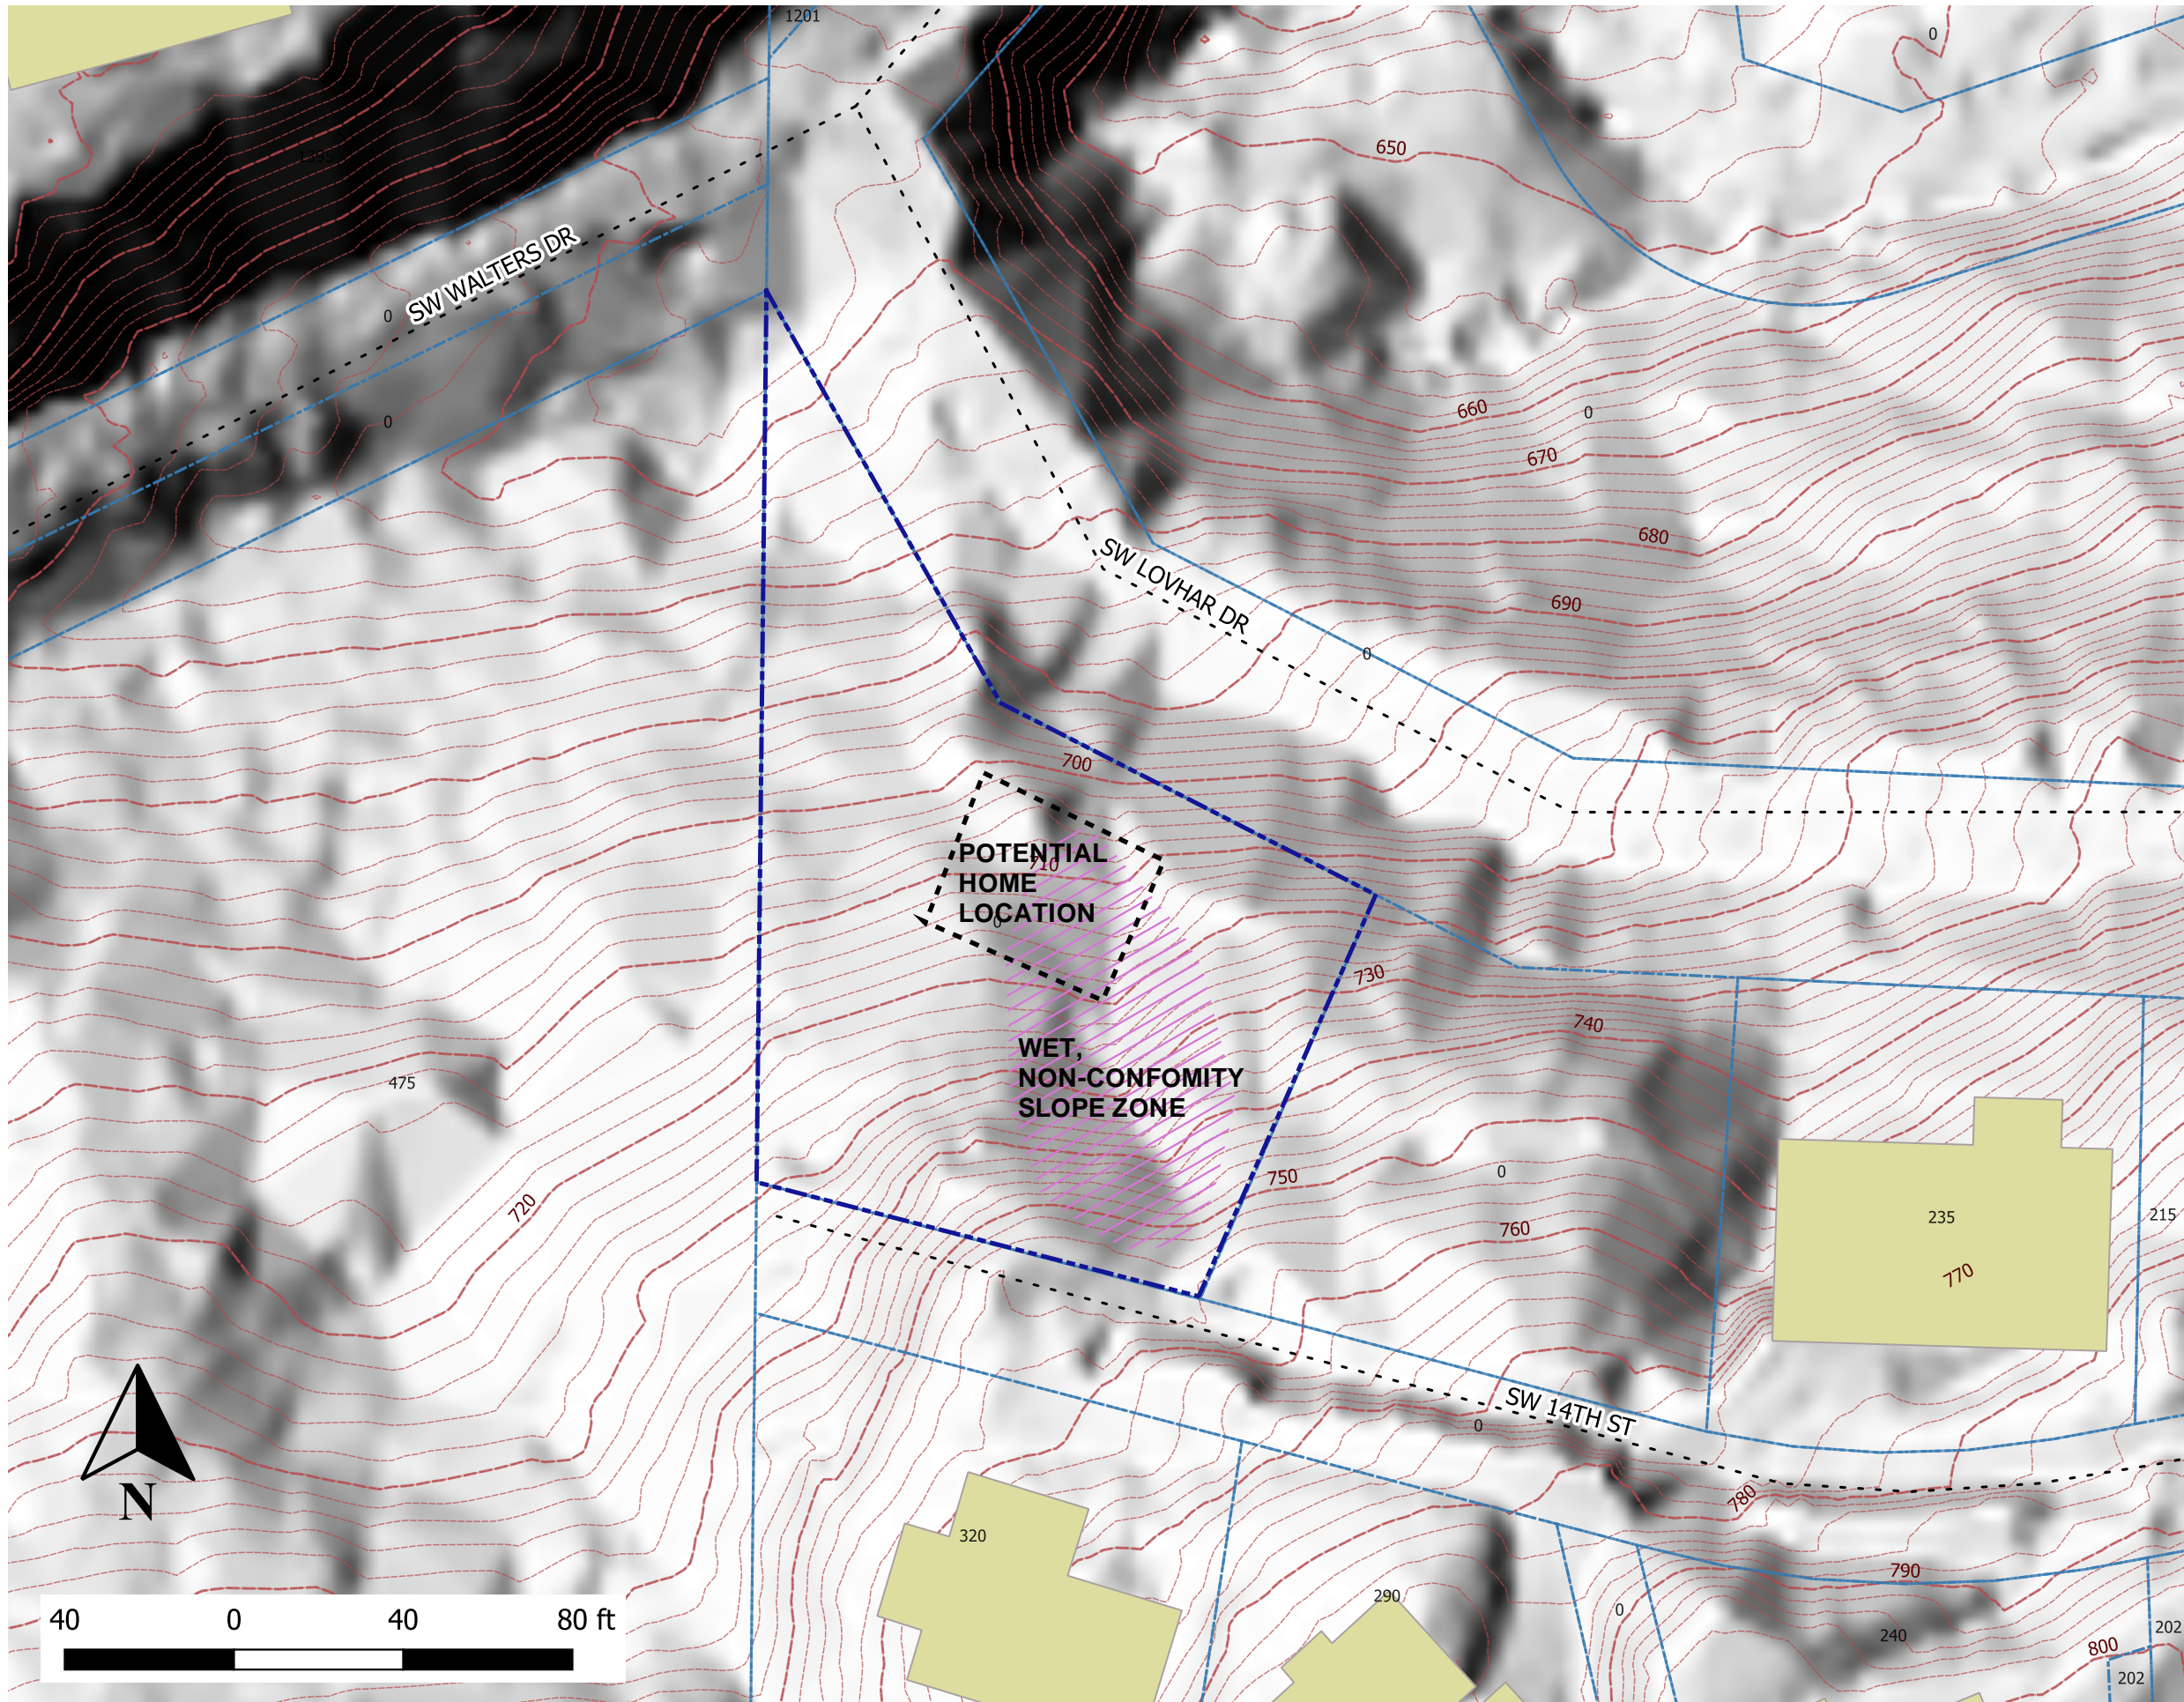
Figure 1

On May 13, 2023, STRATA observed site topography and other surface features to evaluate landslide potential. The property is located on a steep, north facing slope near Elevation 700 feet located along Gresham Butte. The proposed development is limited to this north-central location within the tax lot parcel as shown in concept on Figure 1.

feature of concern being a saturated draw with sharp breaks between grades. This surface feature slopes downward south to north at between 20 and 40 percent, and is highlighted in Figure 1. The understory of the ground surface contains hydrophilic vegetation indicative of seasonally saturated conditions.
