EXISTING CONDITIONS	
NW 1/4 SEC 15, T1S, R3E, W.M.	
CITY OF GRESHAM	
MULTNOMAH COUNTY, OREGON	
JUNE 15, 2023	
DRAWN: DMR	CHECKED: SPF
SCALE 1"=30' ACCOUNT # 364	
Y:\364-013\DWG\364013BASE

LOT 5, BLOCK 1
"BARGER HEIGHTS"

Inventory

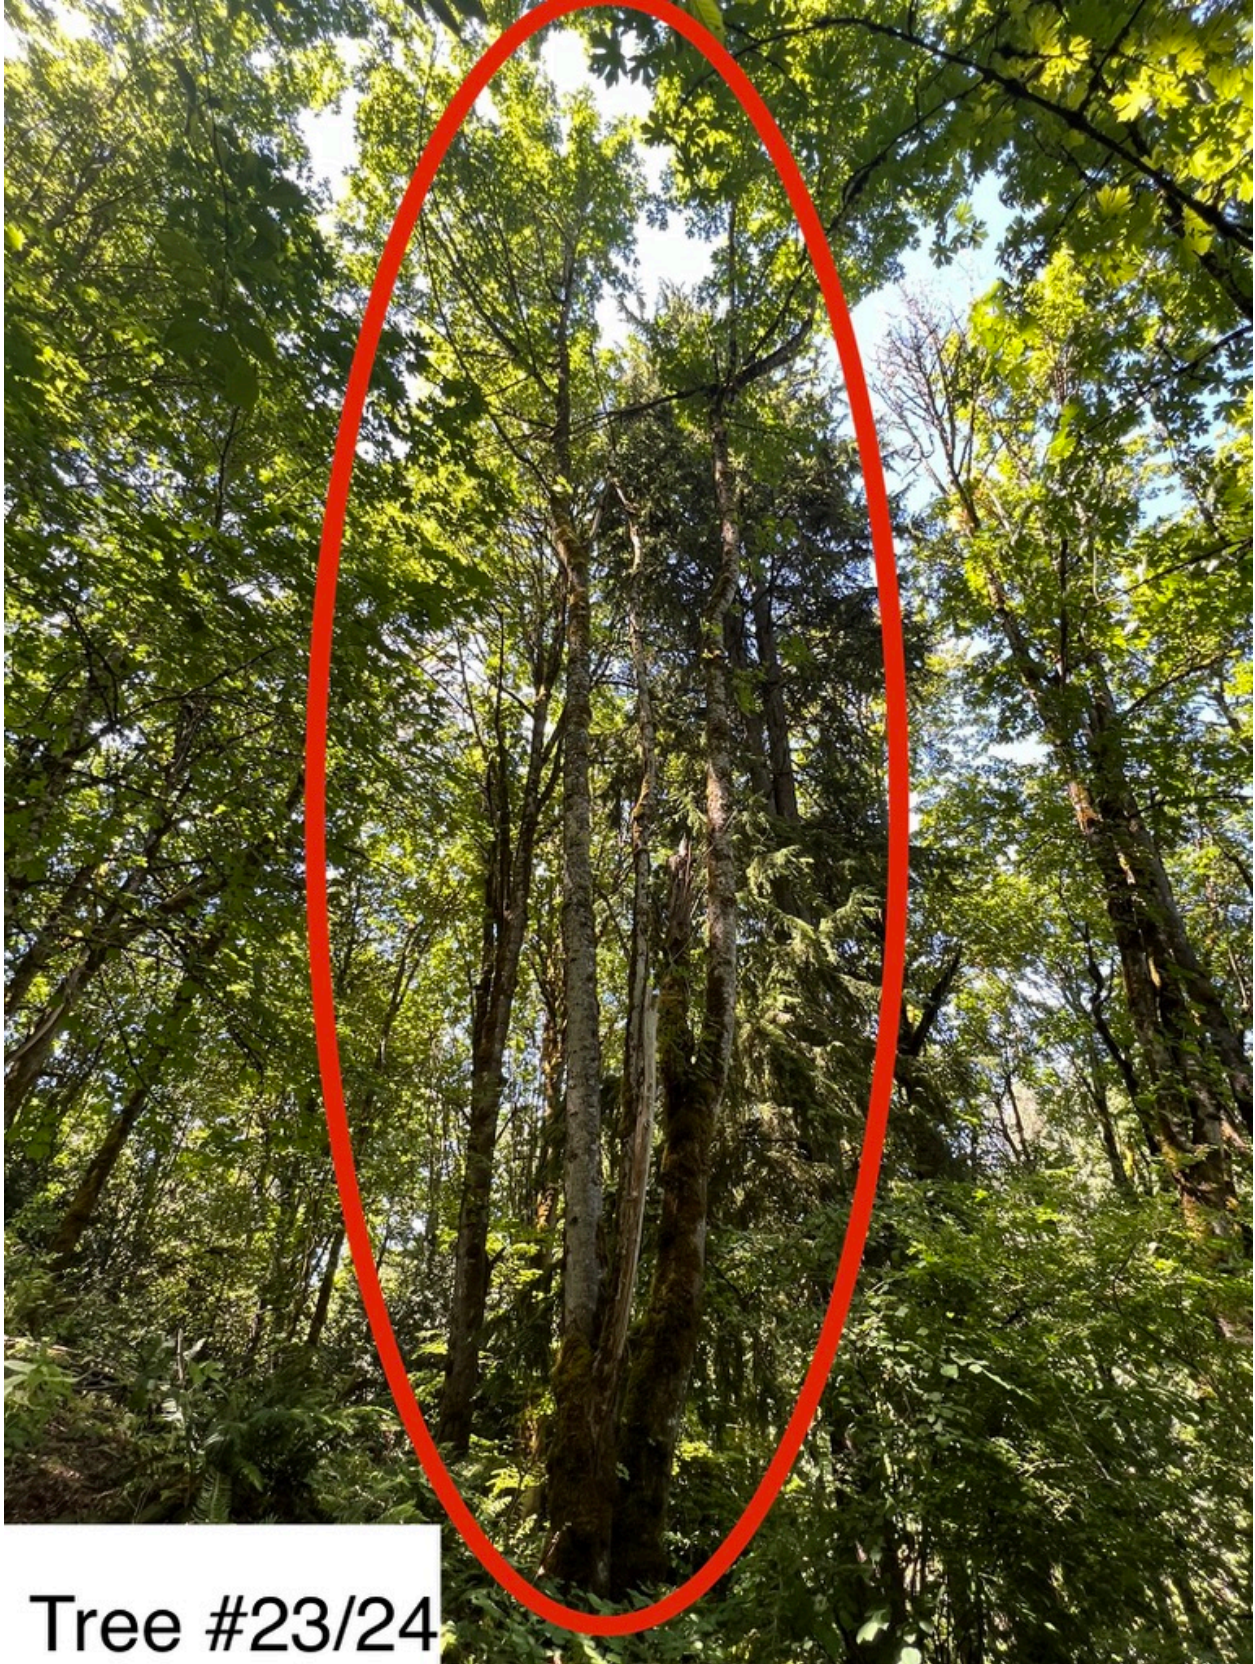
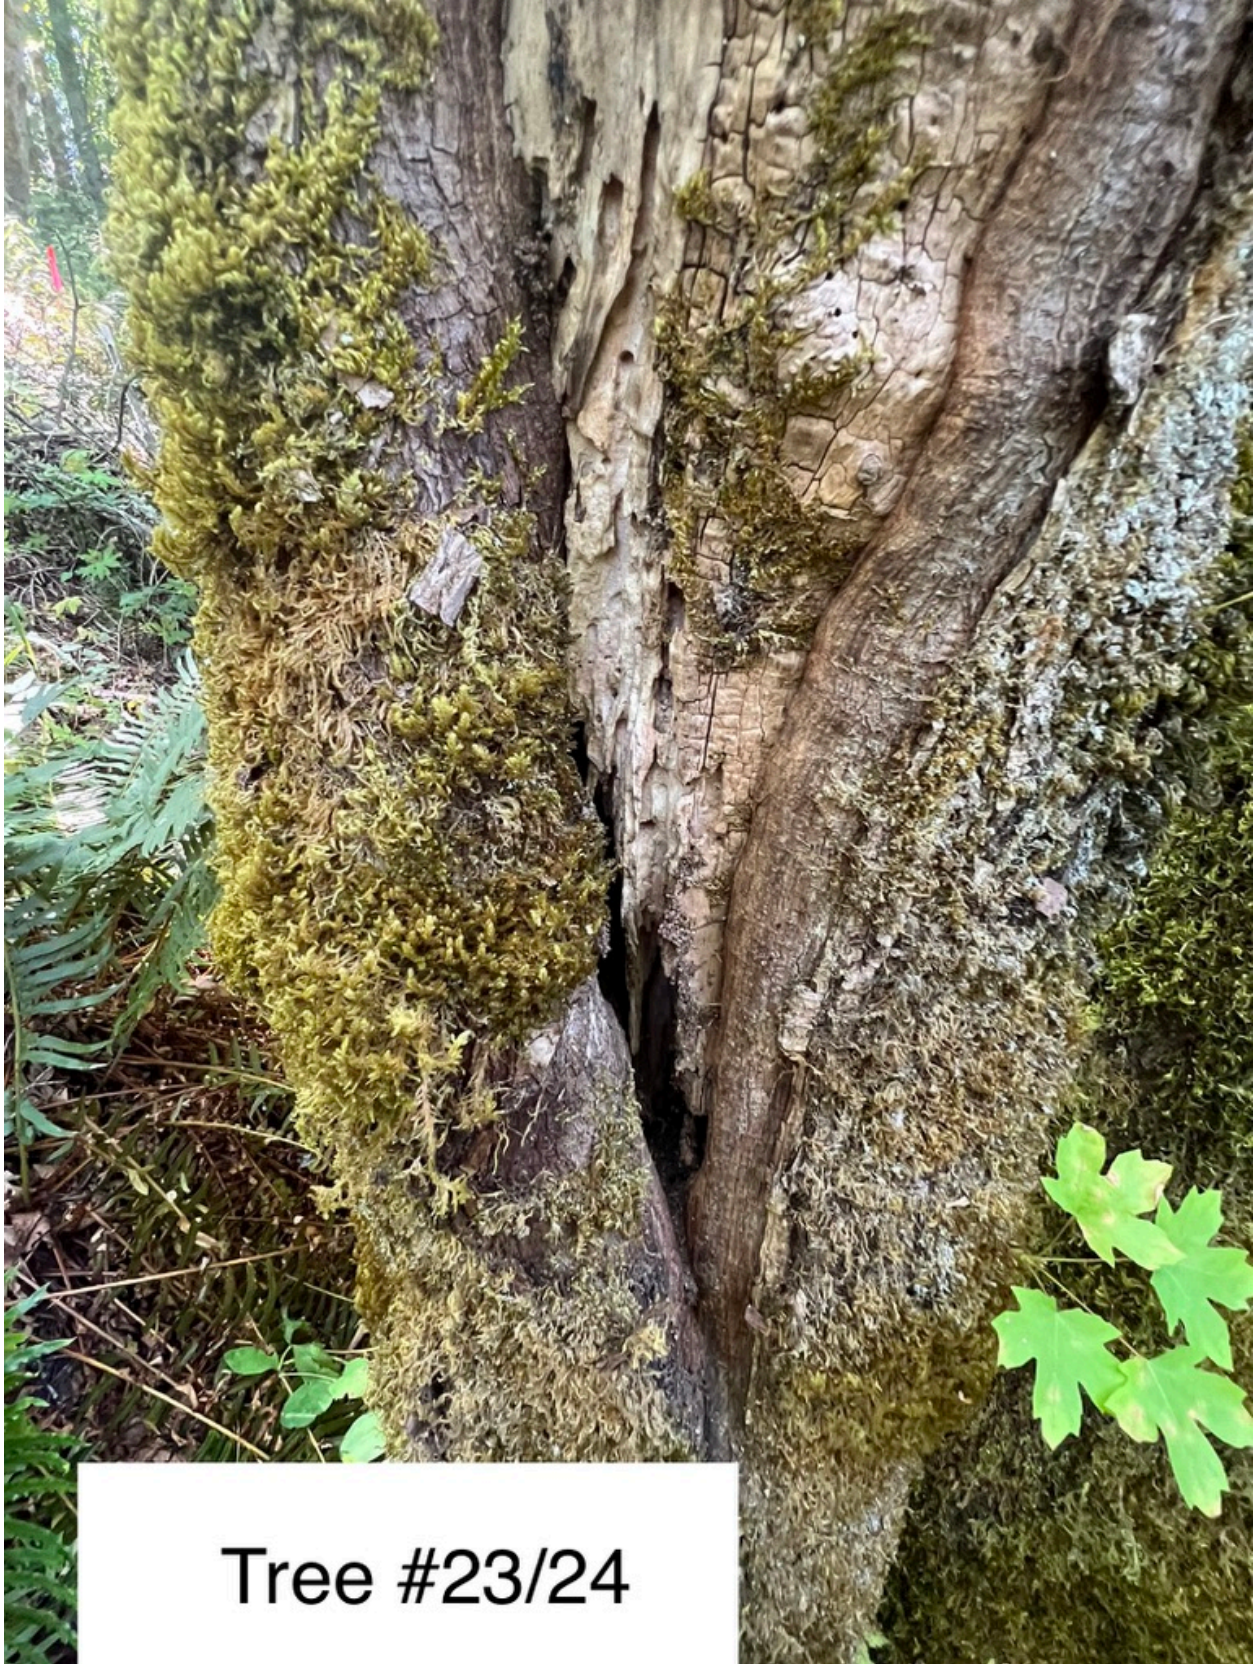
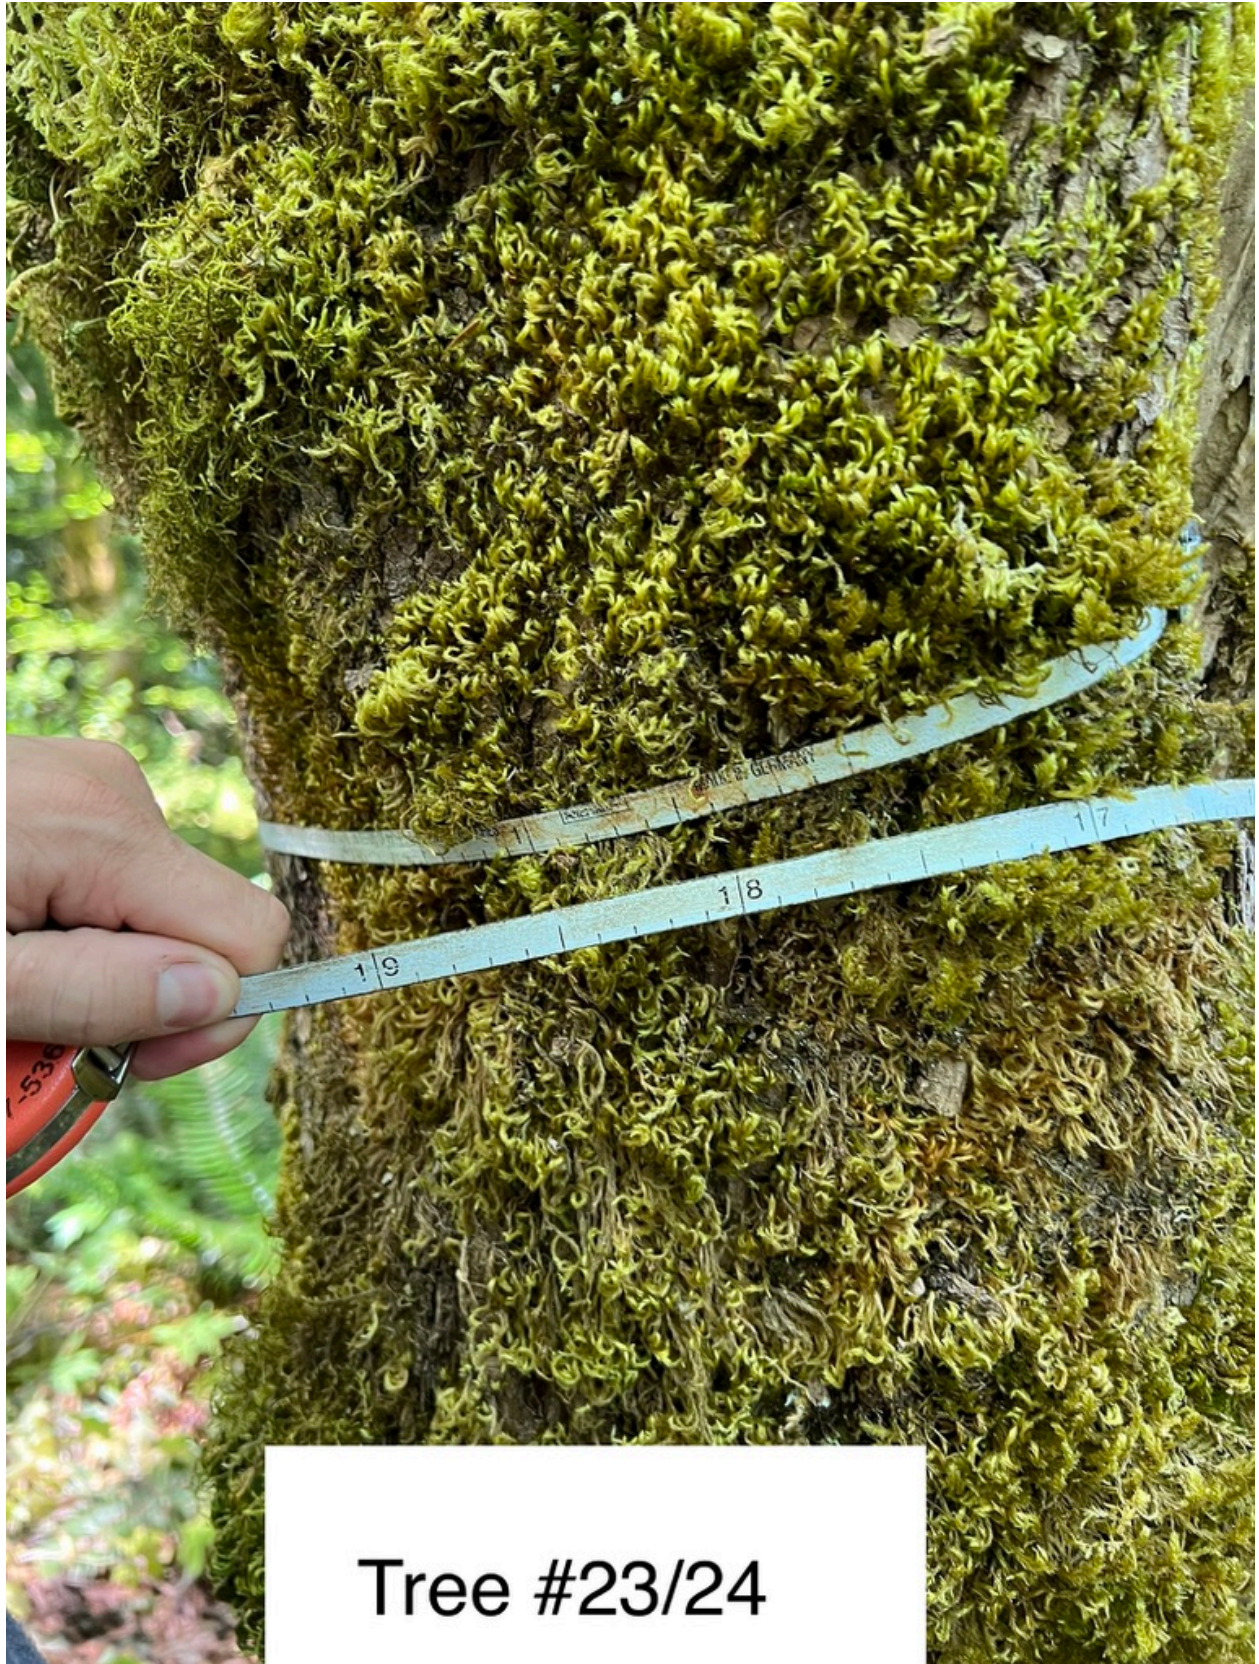
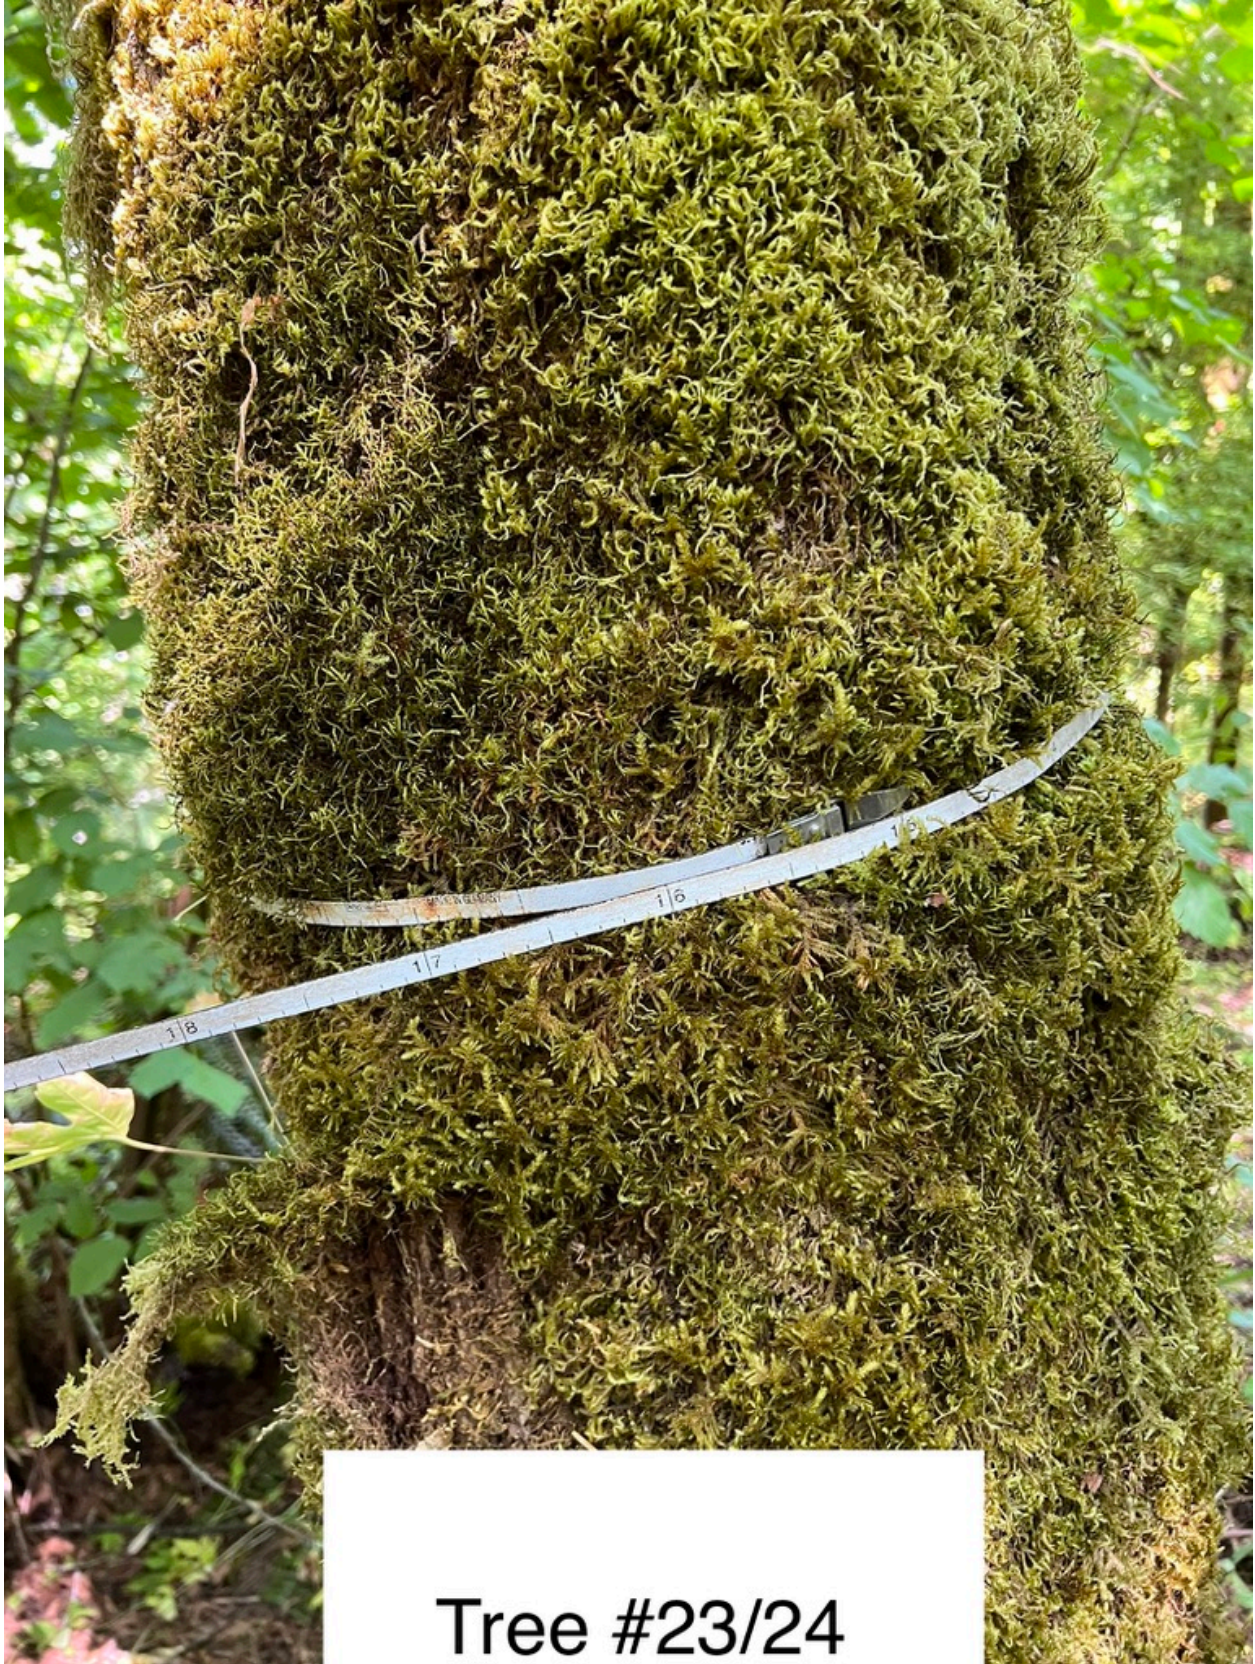
Tree #23/24

Flush cuts Other NA Condition(s) of concern Upper leader failure, dead branch break

Cavity/Nest hole 40 % circ. Depth 7" + Poor taper

Condition(s) of concern Split @ Union

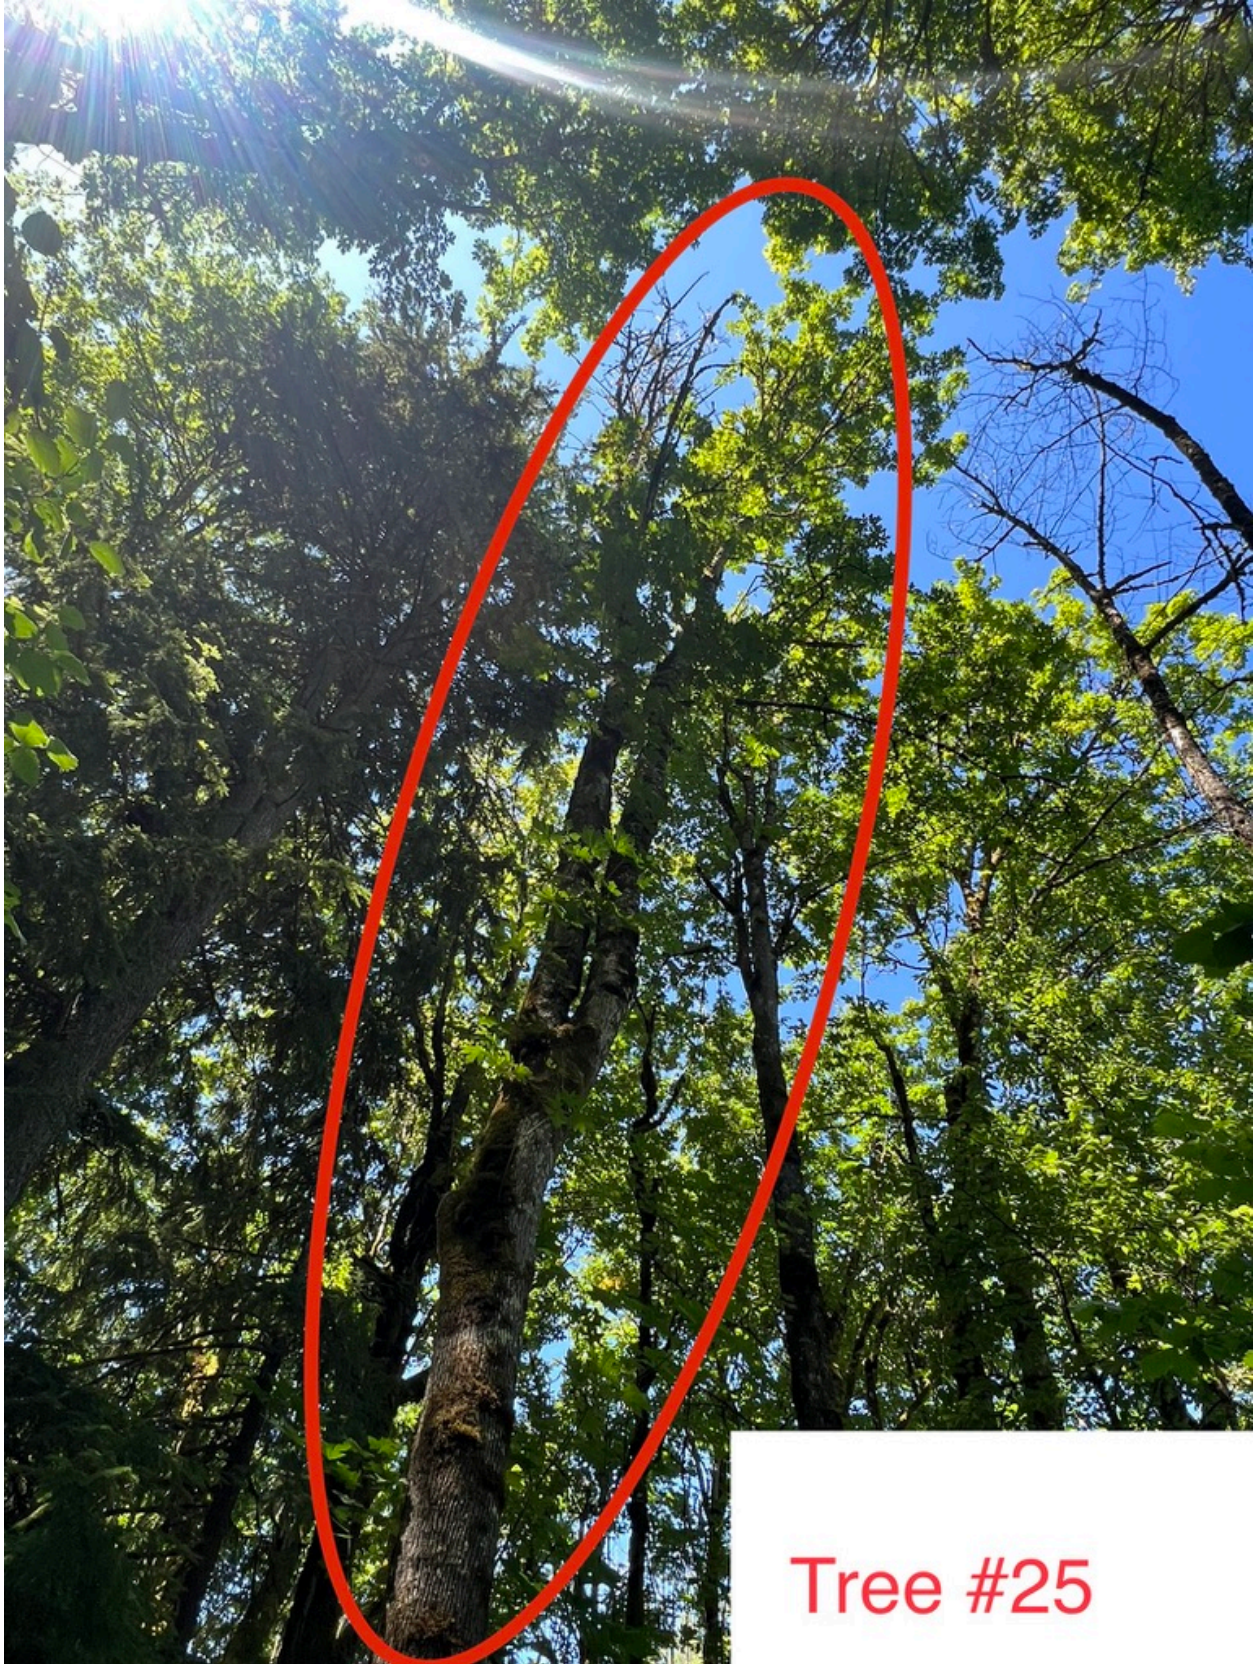
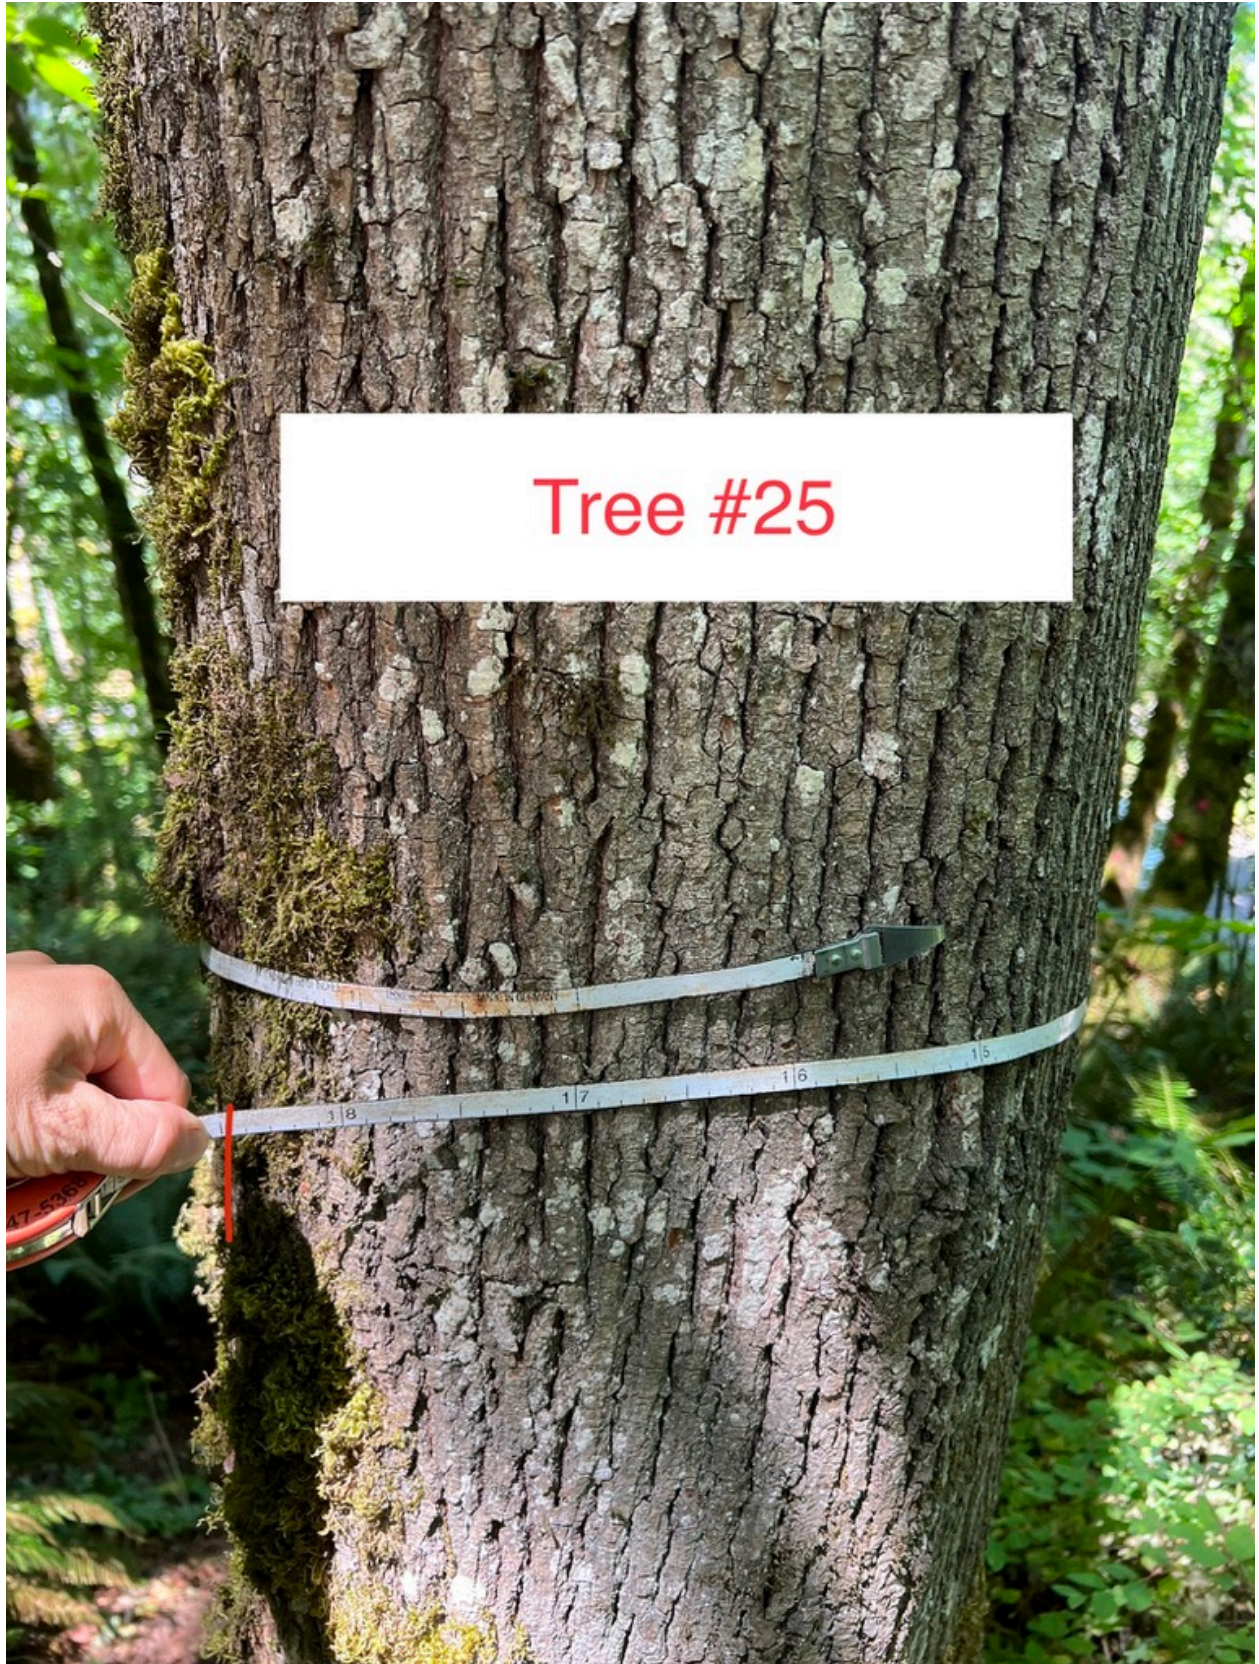
Tree #25

Unbalanced crown LCR 50 %
 Dead twigs/branches 50 % overall Max. dia. 10"
 Broken/Hangers Number NA Max. dia. NA
 Over-extended branches
 Pruning history
 Crown cleaned Thinned Raised
 Reduced Topped Lion-tailed
 Flush cuts Other NA
 Condition(s) of concern Half canopy is dead

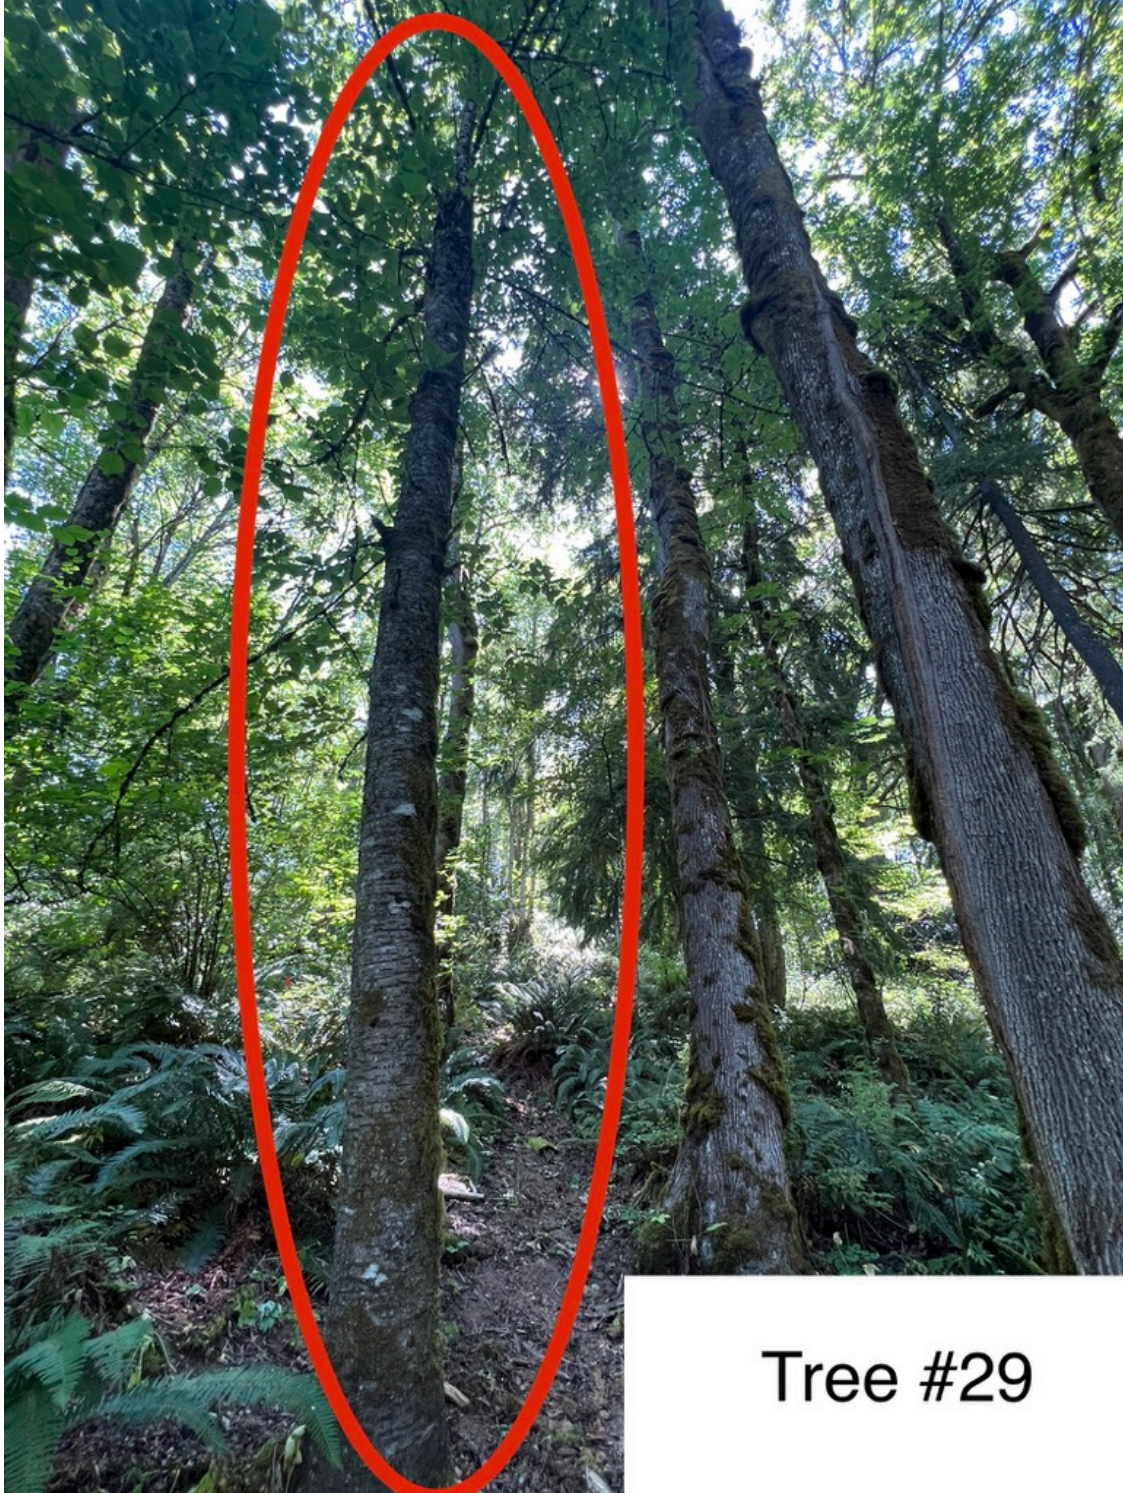
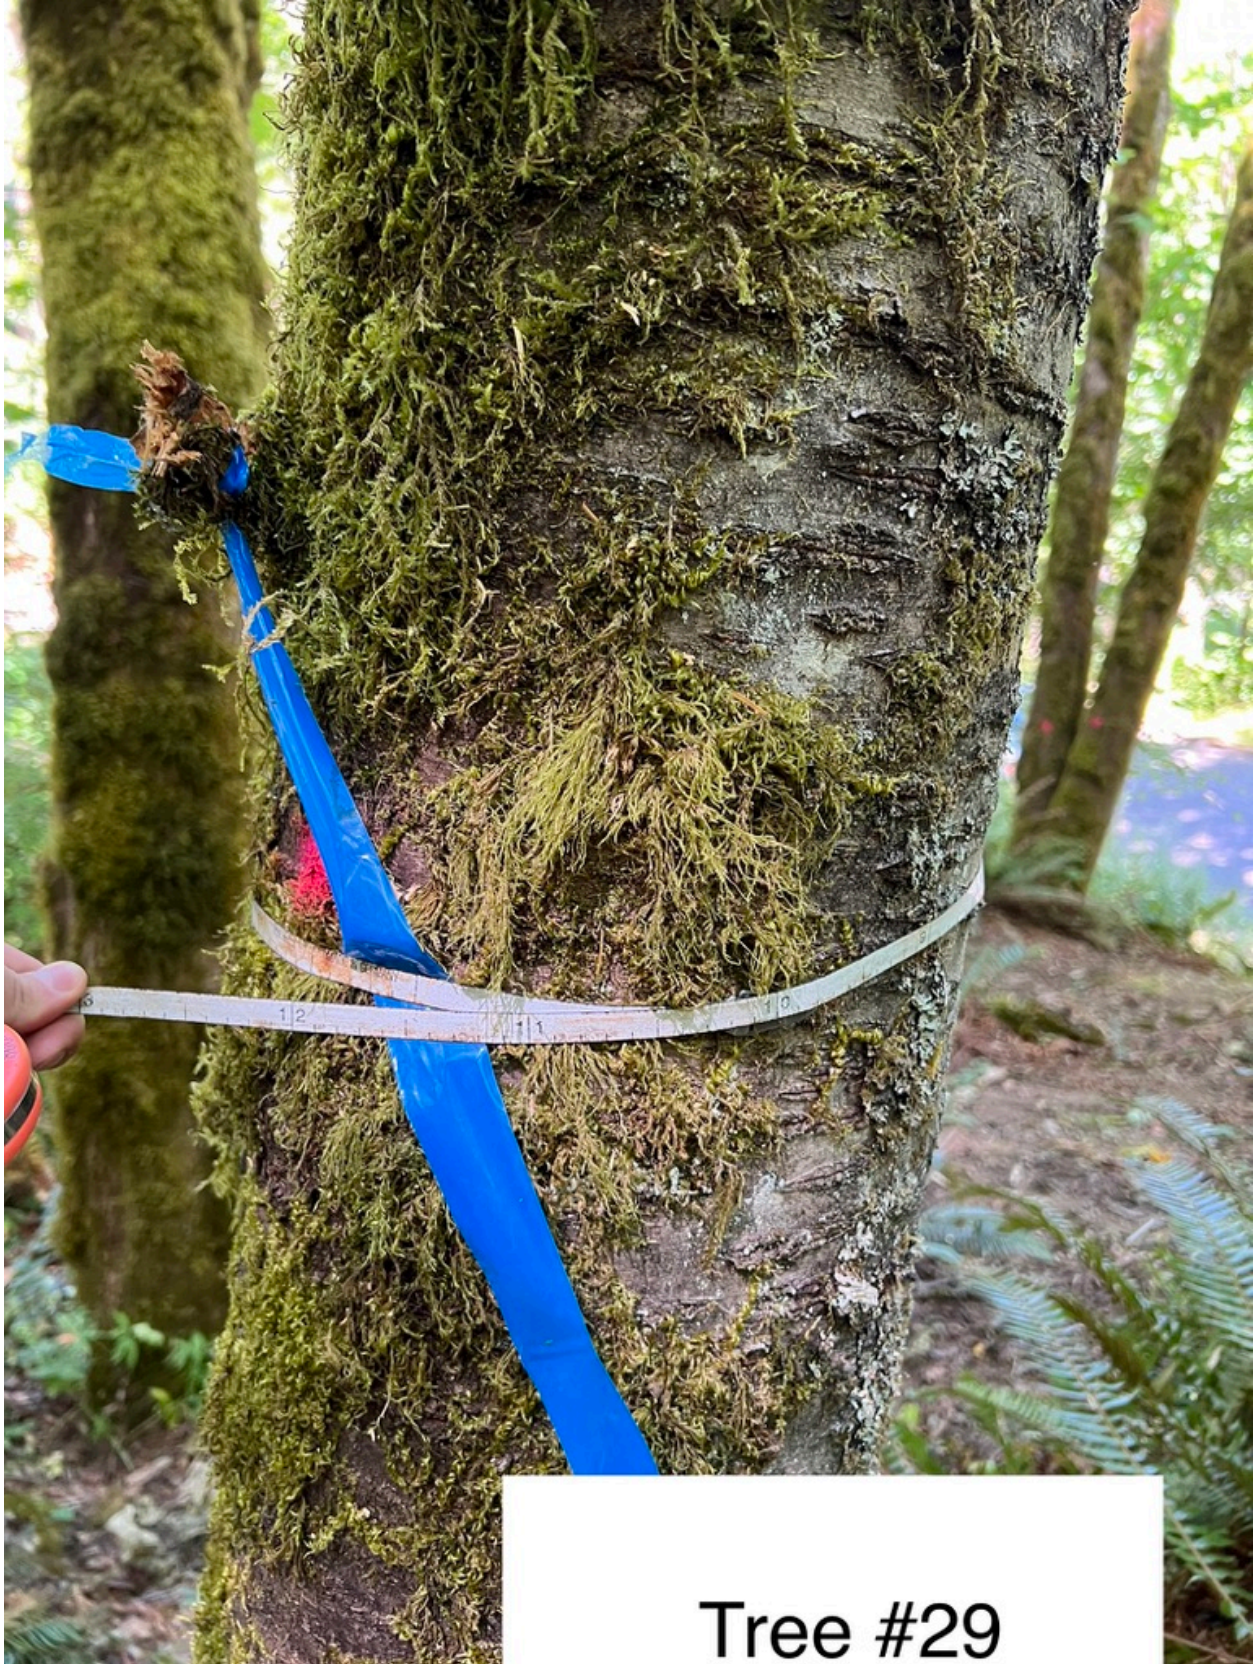
Tree #29

Nuisance cherry, *Prunus avium*. Foliage too high to easily photograph, bark lenticels used for ID

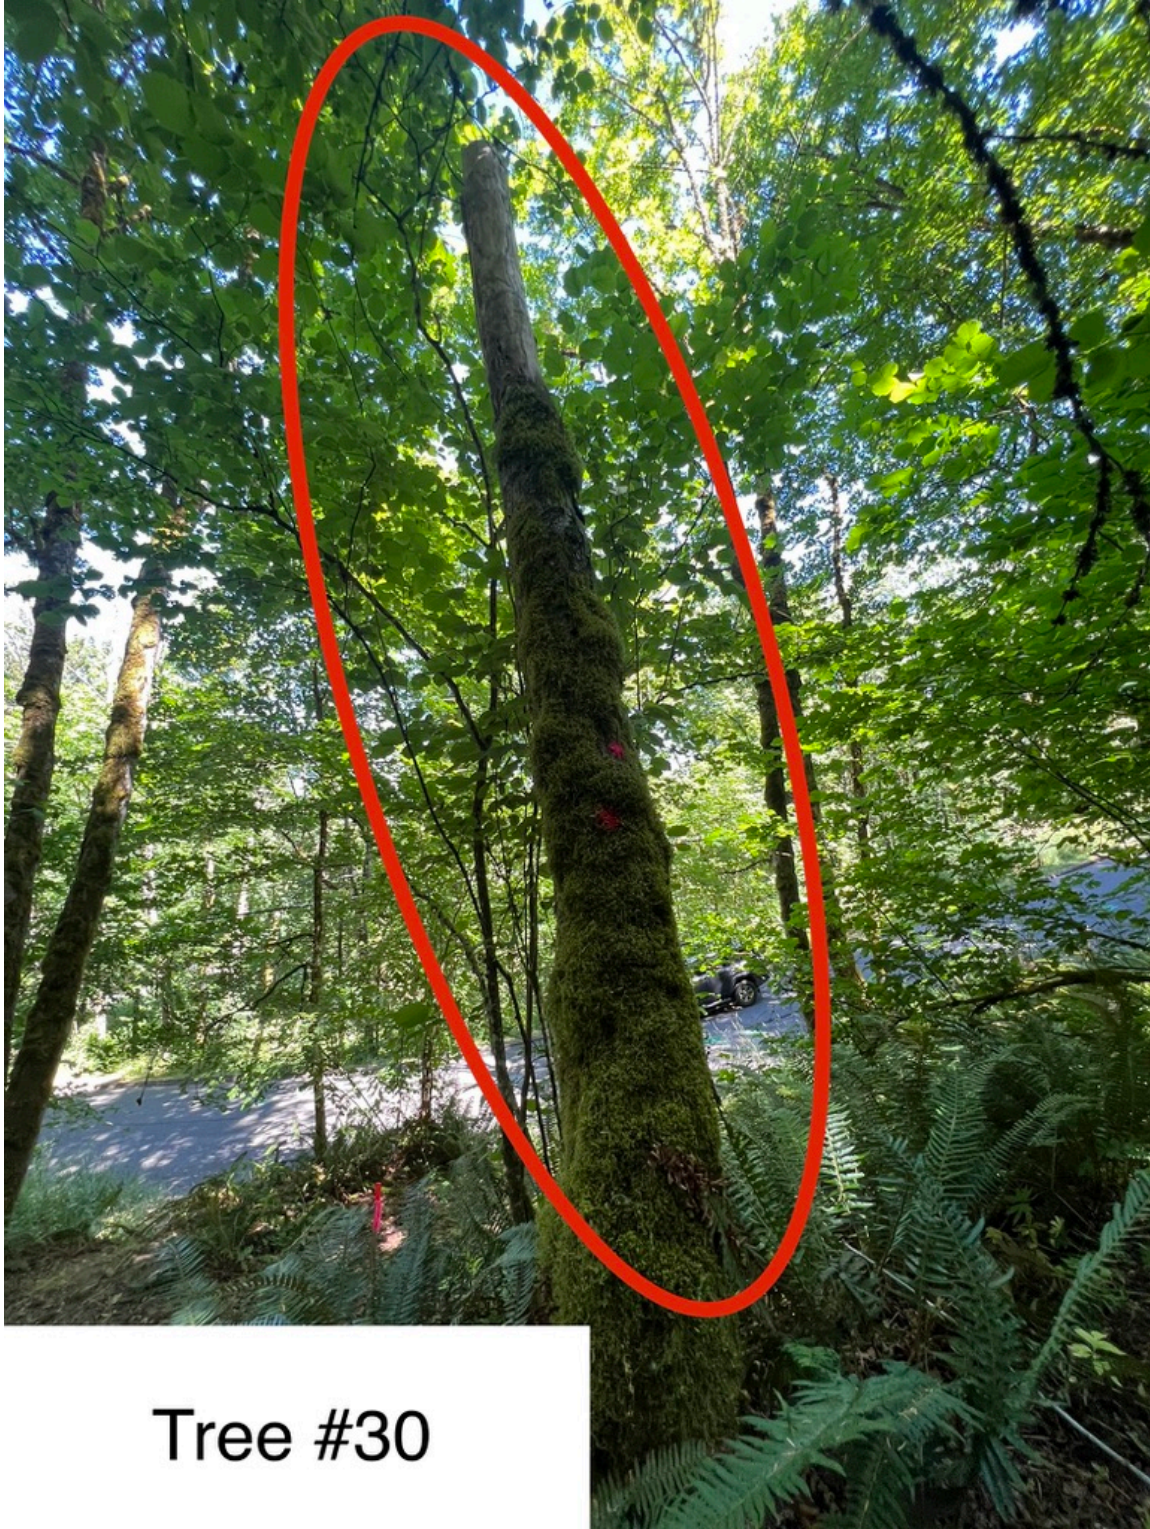
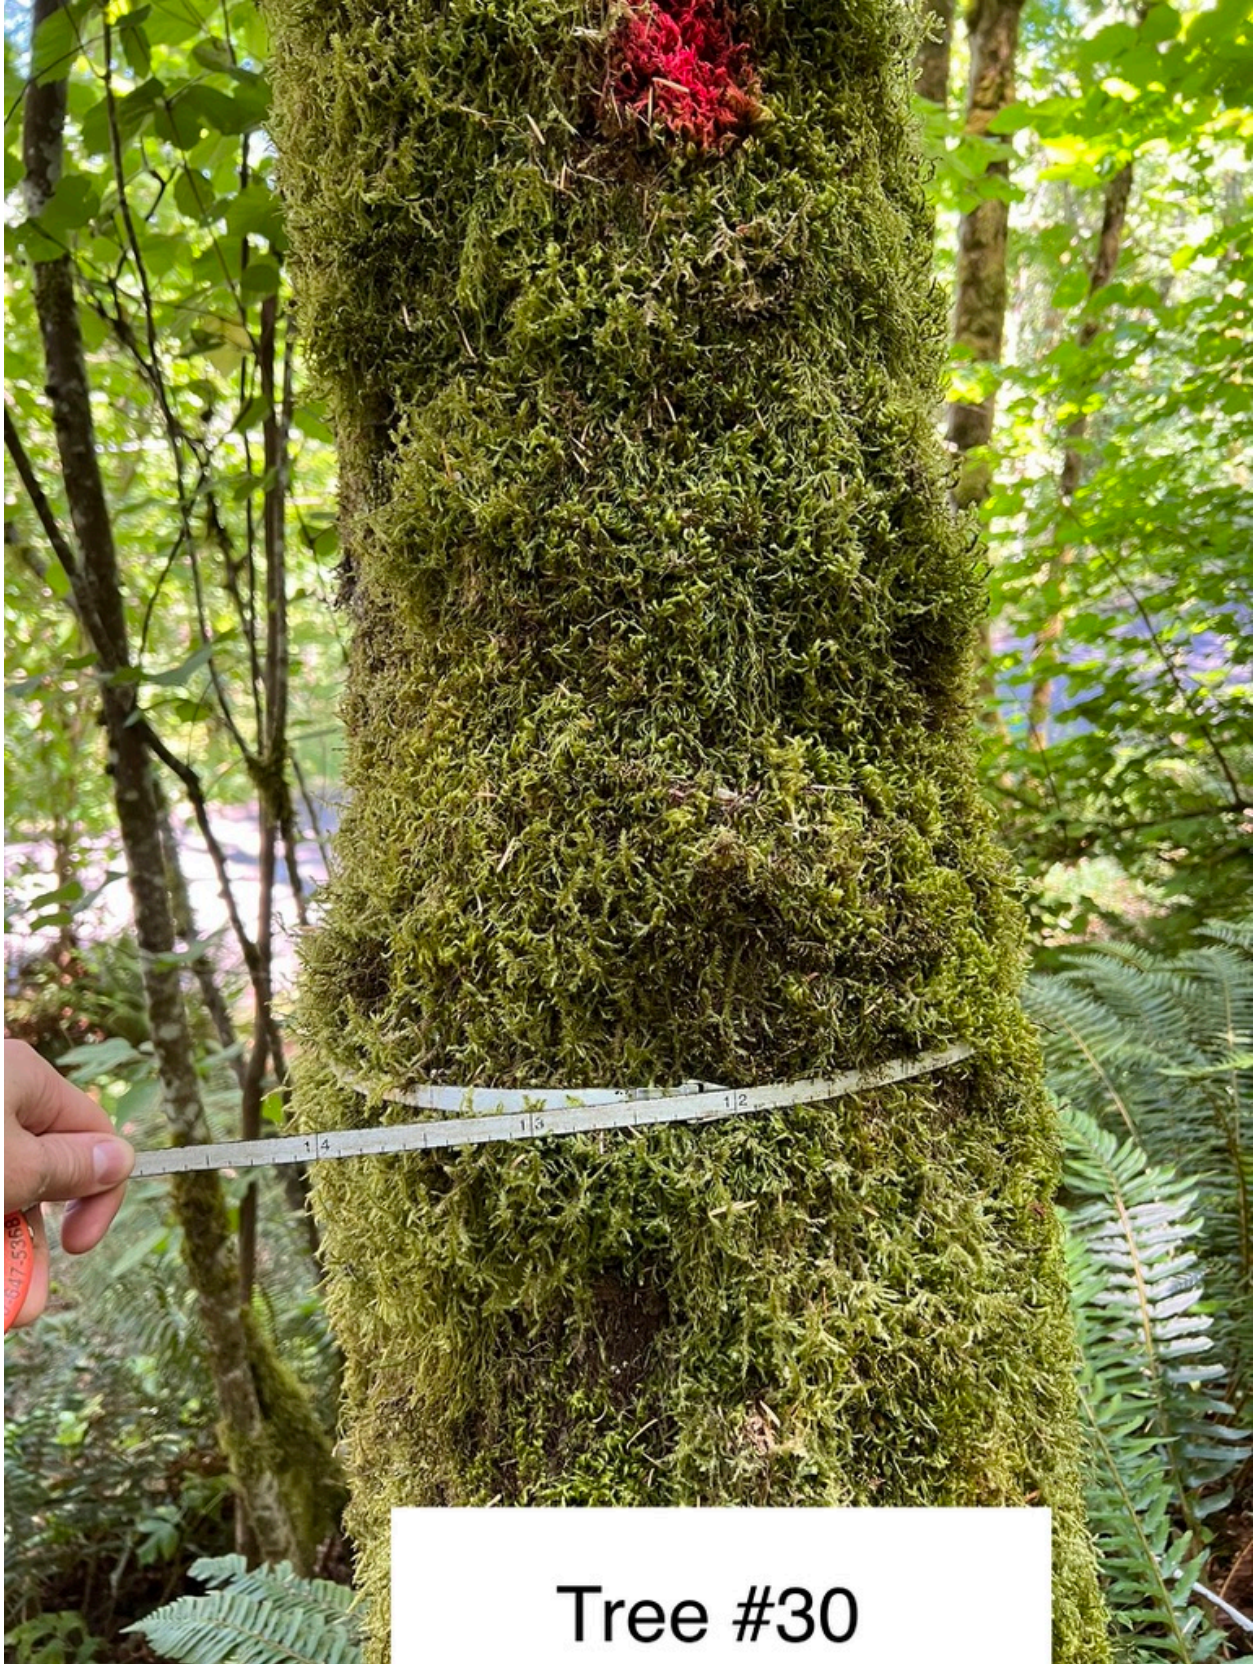
Tree #30

Visibly dead tree
