EXISTING CONDITIONS	
NW 1/4 SEC 15, T1S, R3E, W.M.	
CITY OF GRESHAM	
MULTNOMAH COUNTY, OREGON	
JUNE 15, 2023	
DRAWN: DMR	CHECKED: SPF
SCALE 1"=30' ACCOUNT # 364	
Y:\364-013\DWG\364013BASE

LOT 5, BLOCK 1
"BARGER HEIGHTS"

Inventory

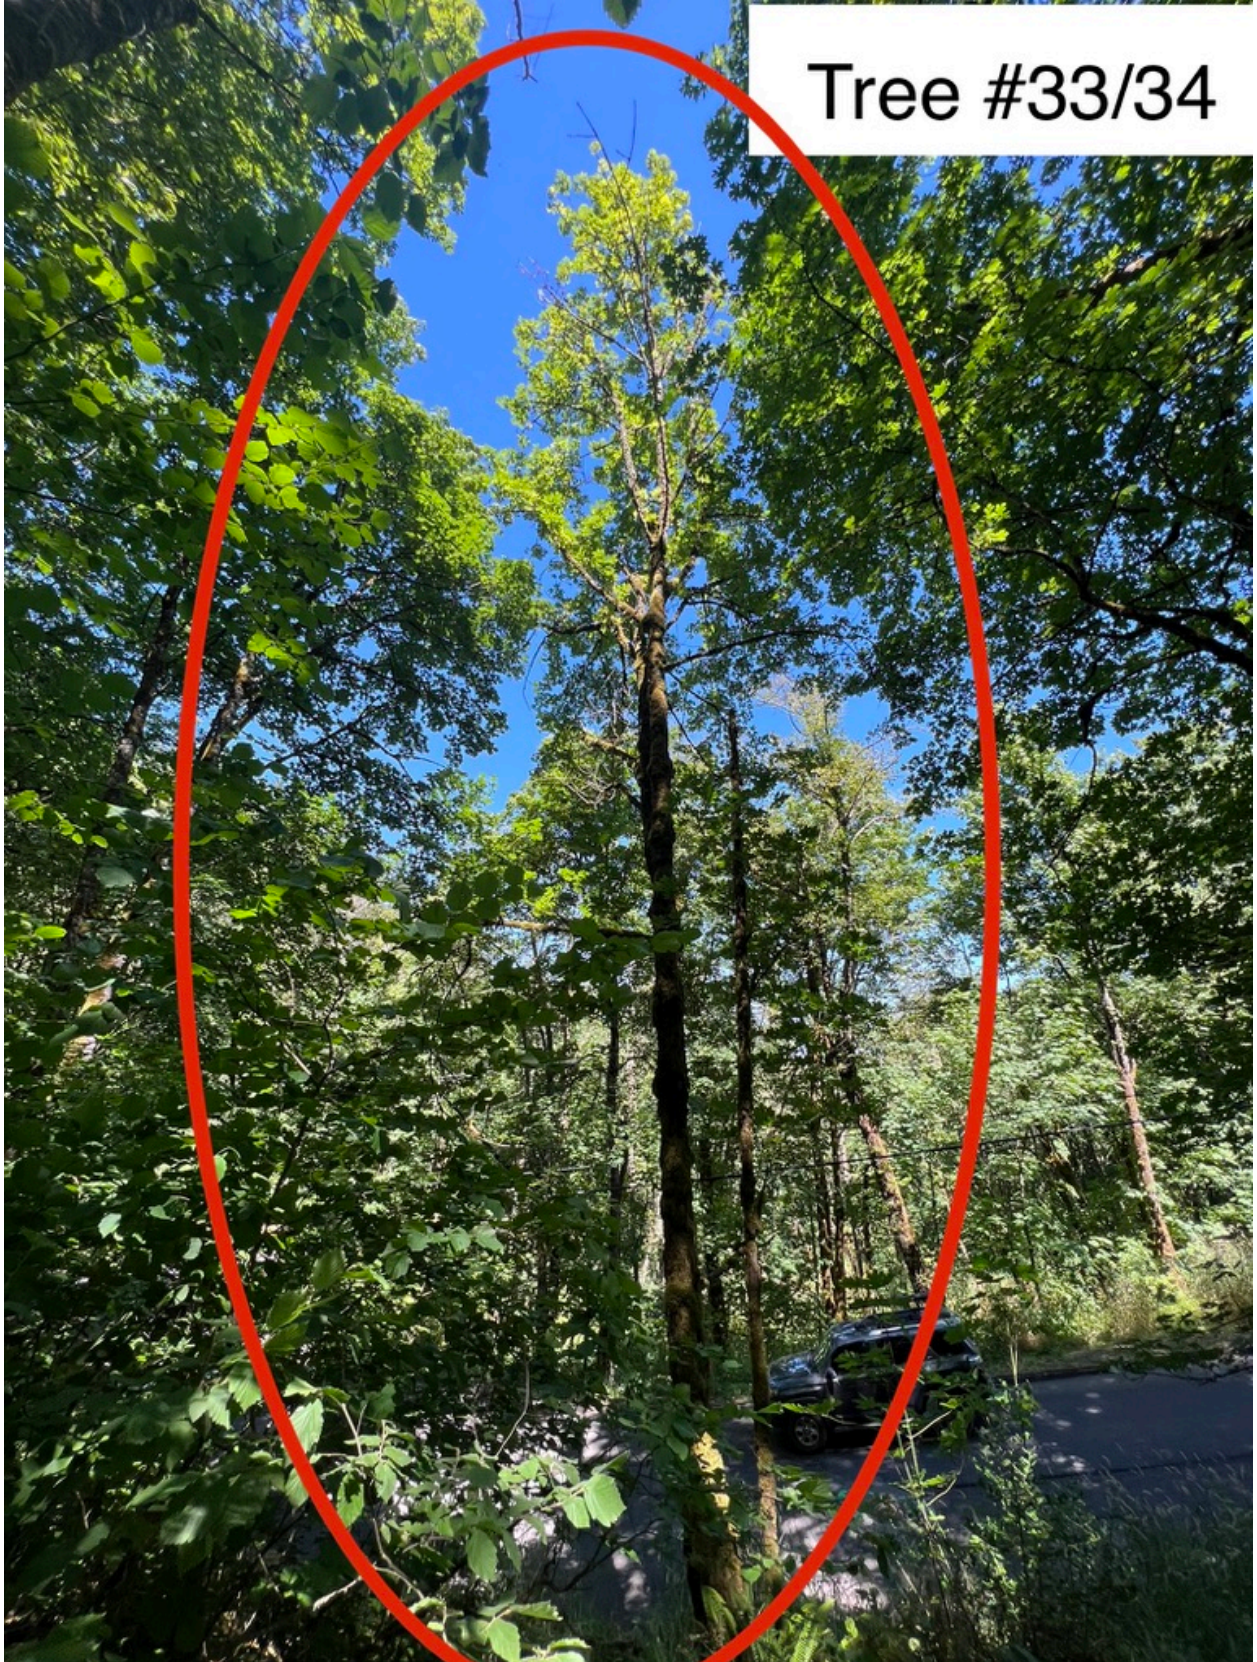
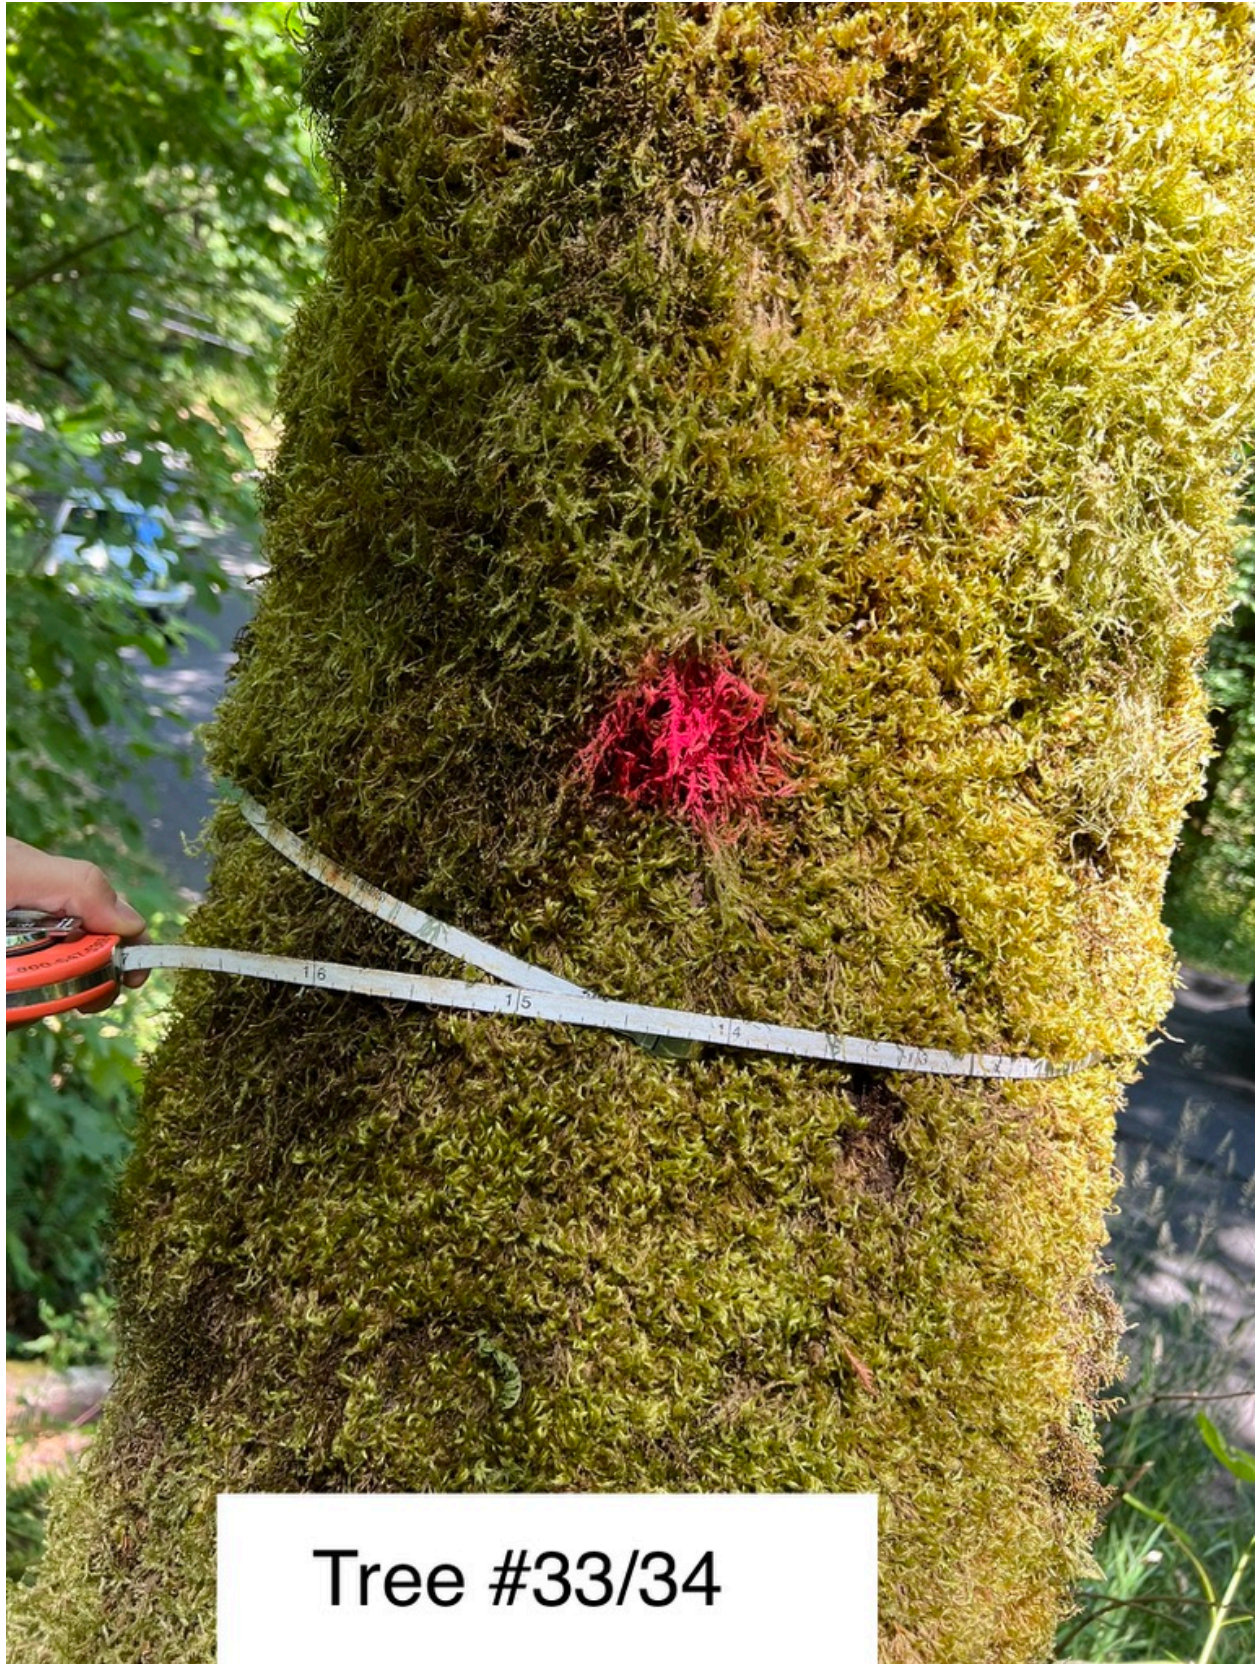
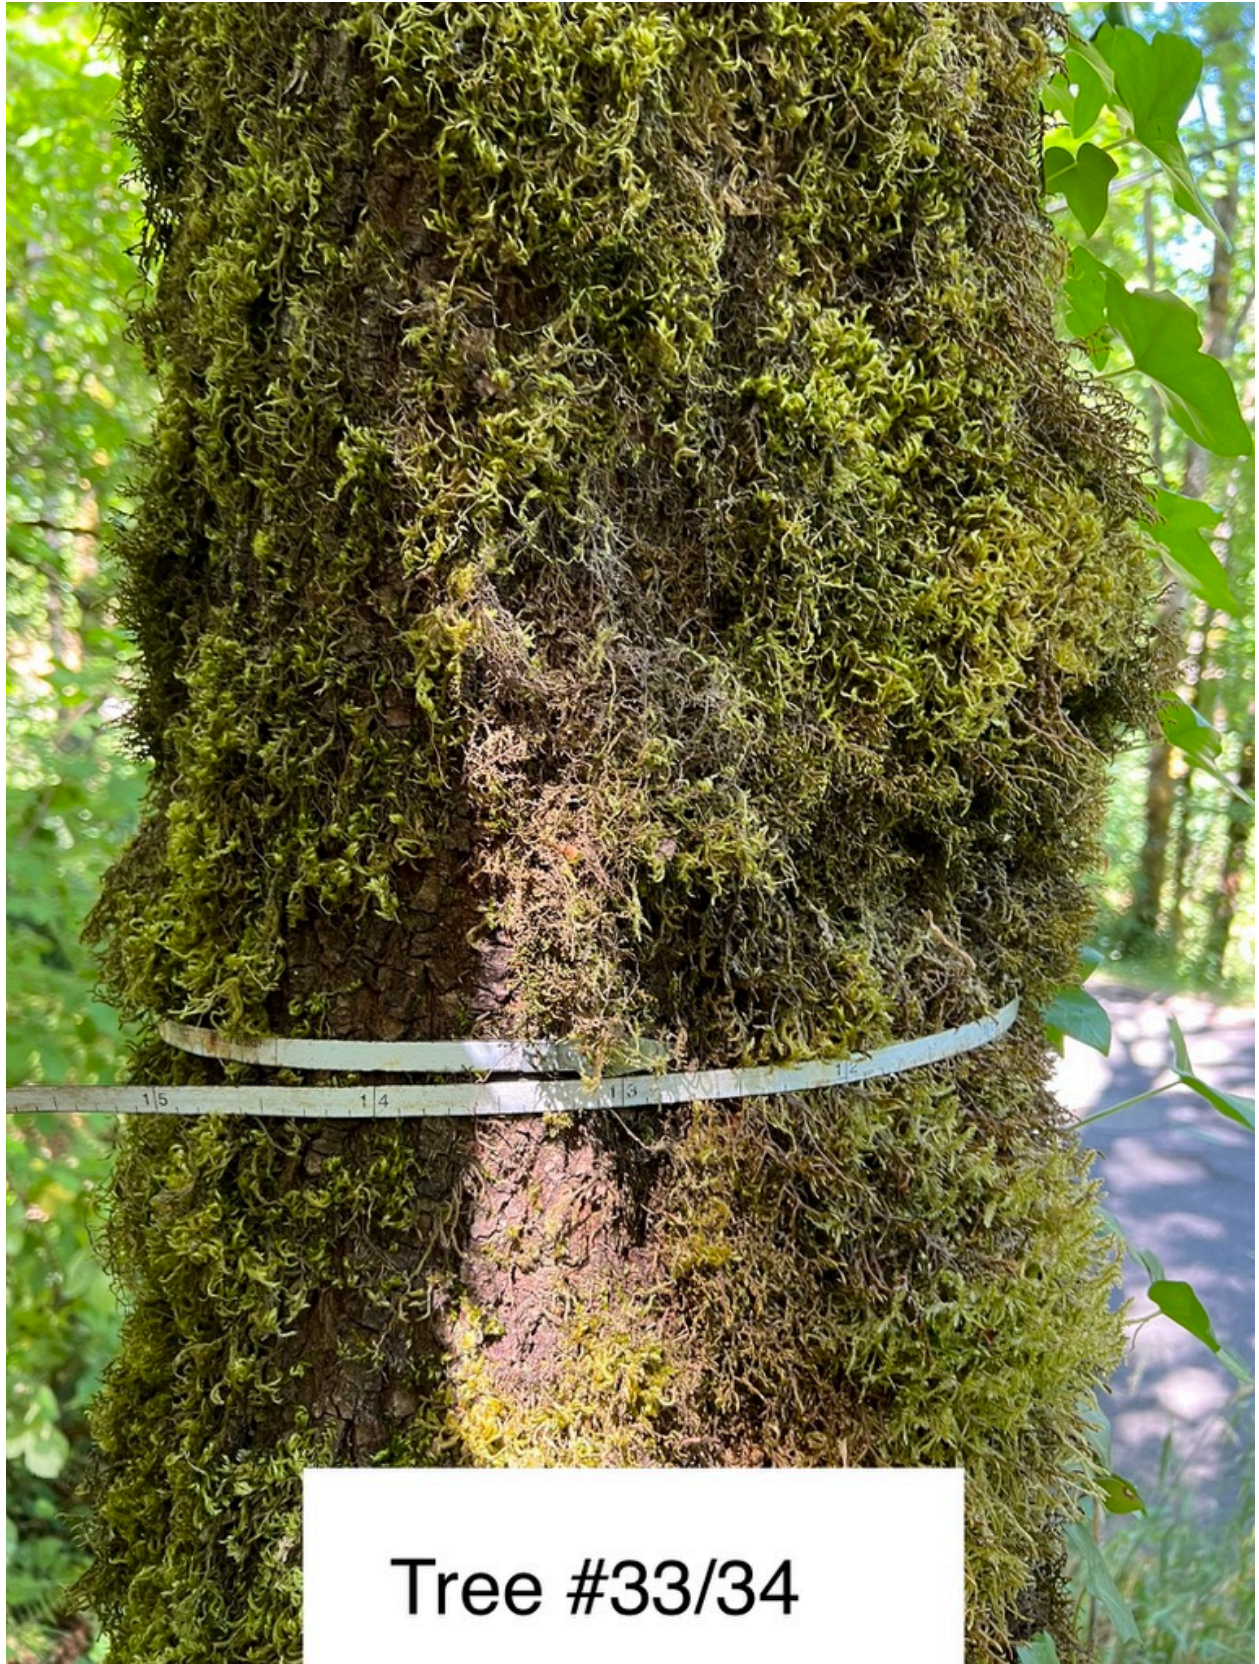
Tree #33/34

Dead/Missing bark Abnormal bark texture/color
 Codominant stems Included bark Cracks
 Sapwood damage/decay Cankers/Galls/Burls Sap ooze
 Lightning damage Heartwood decay Conks/Mushrooms
 Cavity/Nest hole NA % circ. Depth NA Poor taper
 Lean 10° Corrected? yes
 Response growth NA
 Condition(s) of concern Codominant lean fail
 Part Size 23" Fall Distance 9'
 Load on defect N/A Minor Moderate Significant
 Likelihood of failure Improbable Possible Probable Imminent

Risk Categorization																	
Target (Target number or description)	Tree part	Condition(s) of concern	Likelihood							Consequences			Risk rating (from Matrix 2)				
			Failure			Impact				Failure & Impact (from Matrix 1)							
			Improbable	Possible	Probable	Very low	Low	Medium	High	Unlikely	Somewhat	Likely		Very likely	Negligible	Minor	Significant
1	Dead top/crown	Top fail on HV line			X						X					X	High
2	trunk	Codominant + Fail on HV line			X					X		X				X	High

Proximity to high voltage coupled with lean + existing dieback makes this tree a fire risk

1. Remove Residual risk None
2. Residual risk _____
3. Residual risk _____
4. Residual risk _____

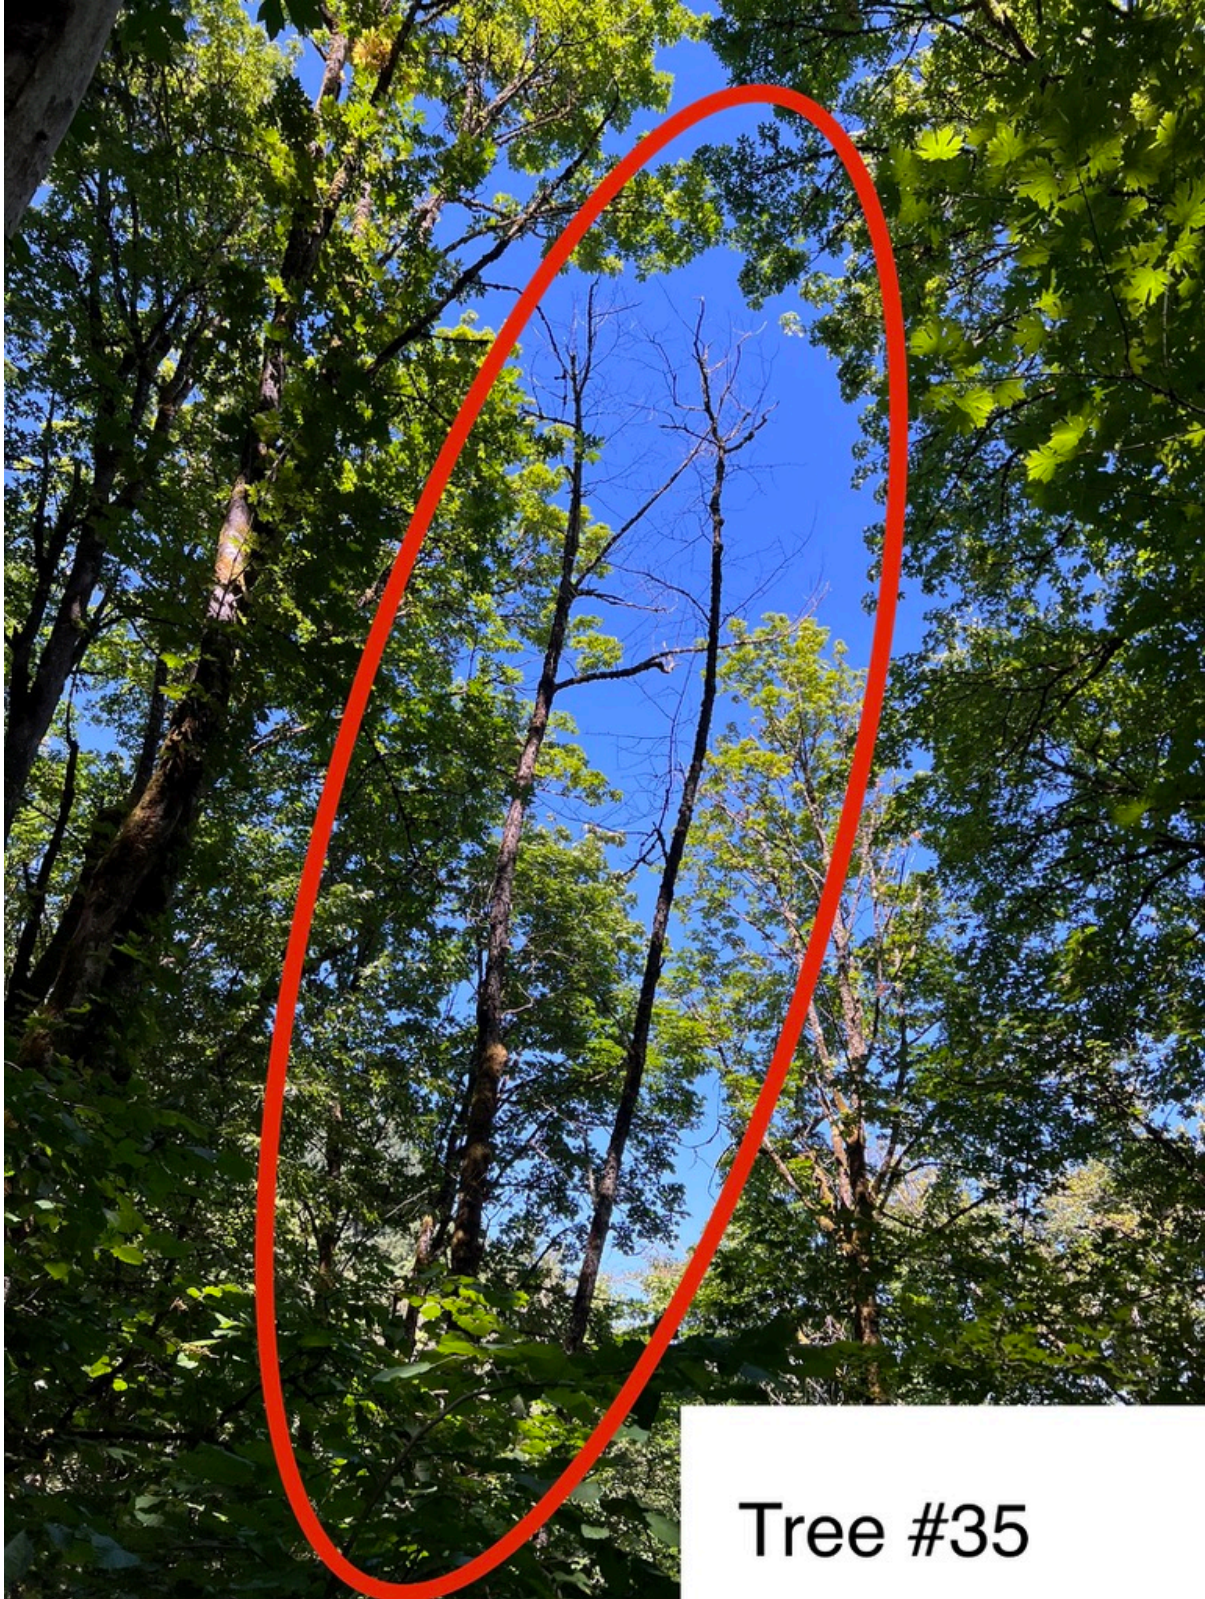
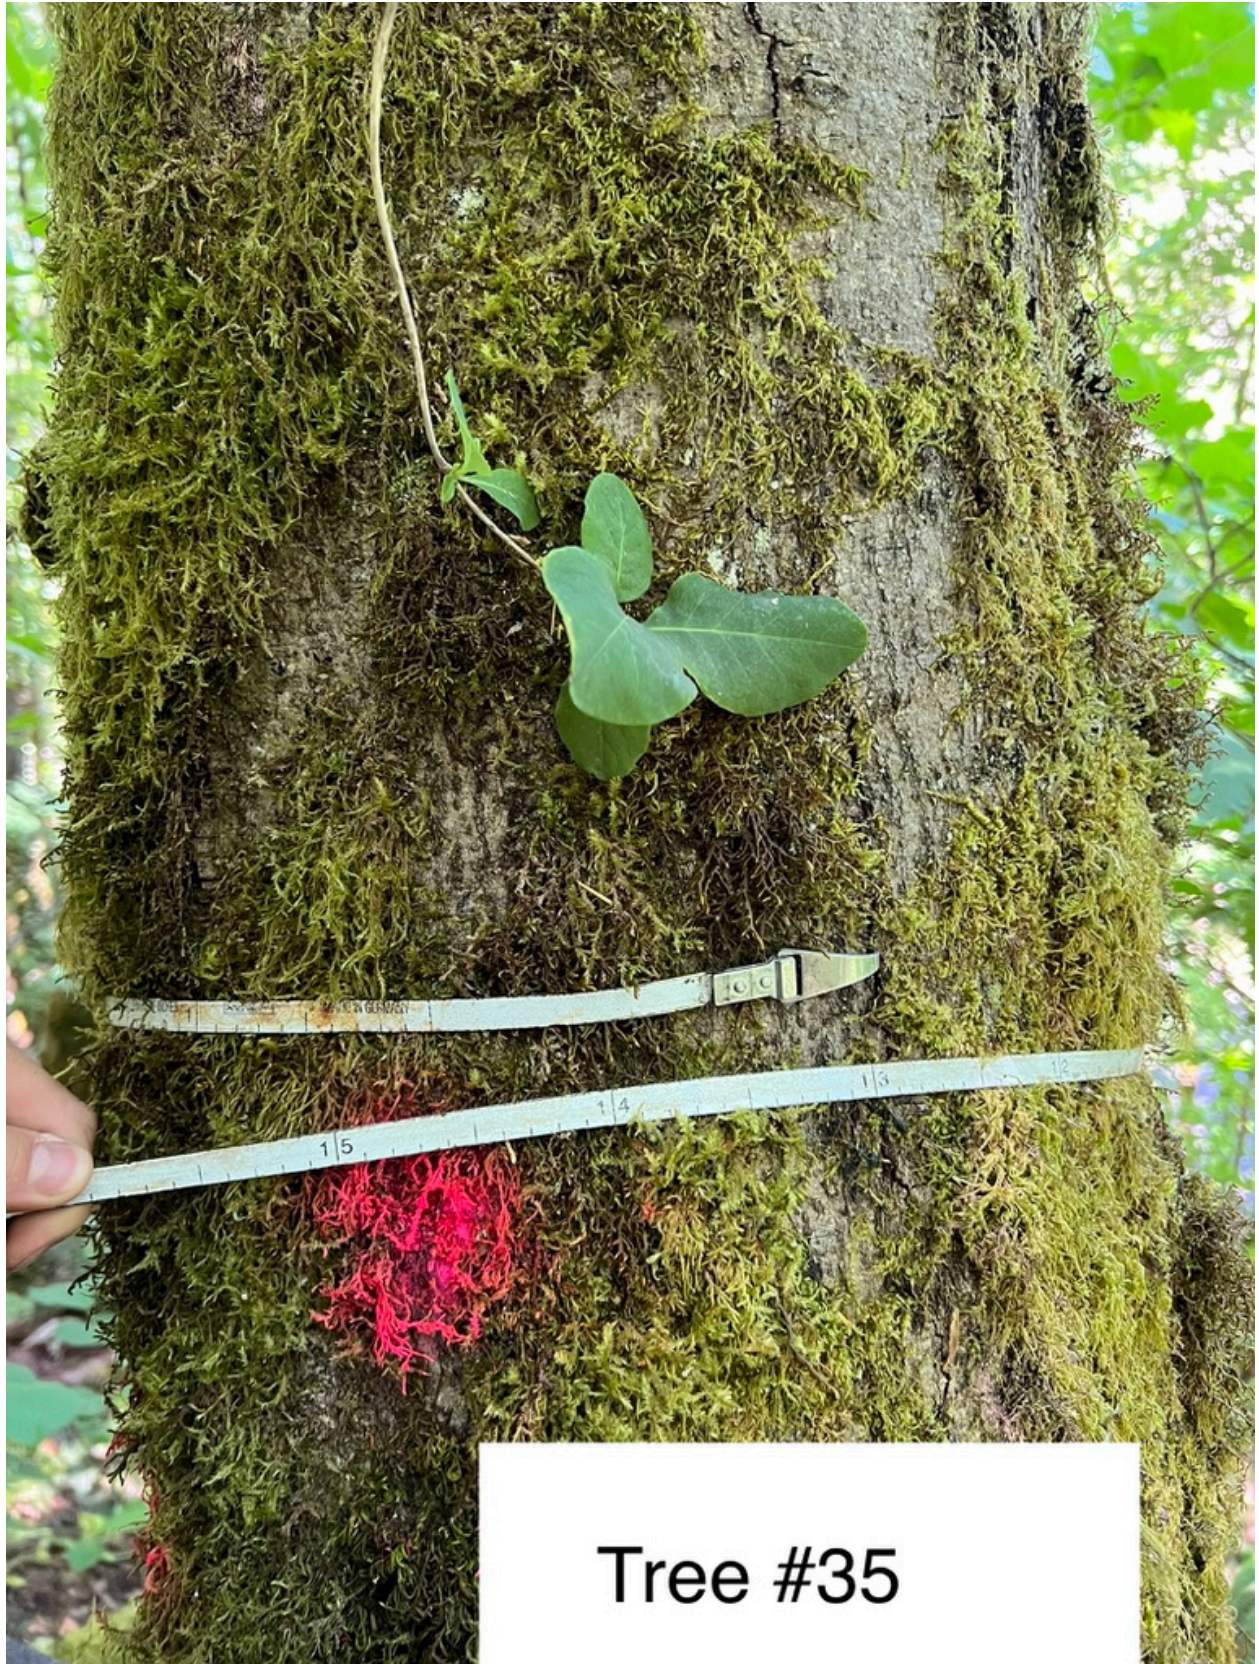
Tree #35

Visibly dead

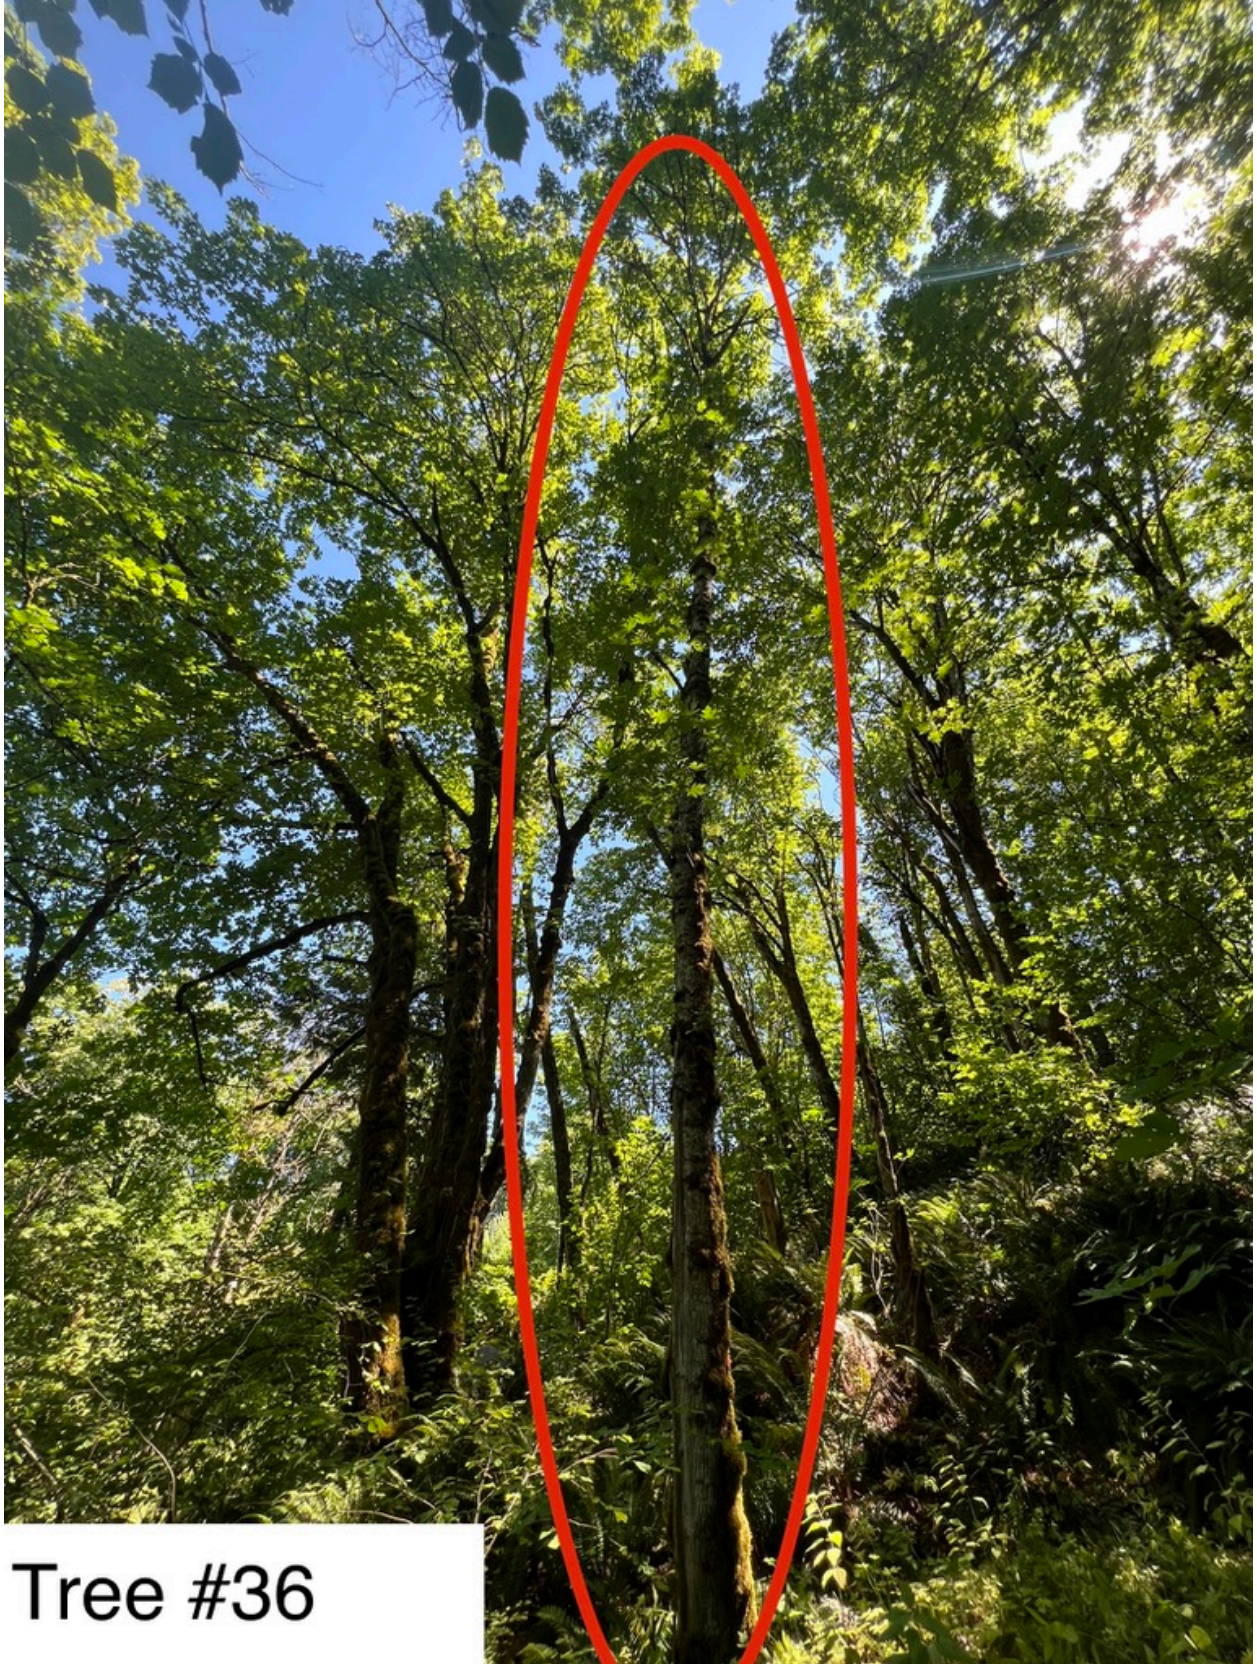
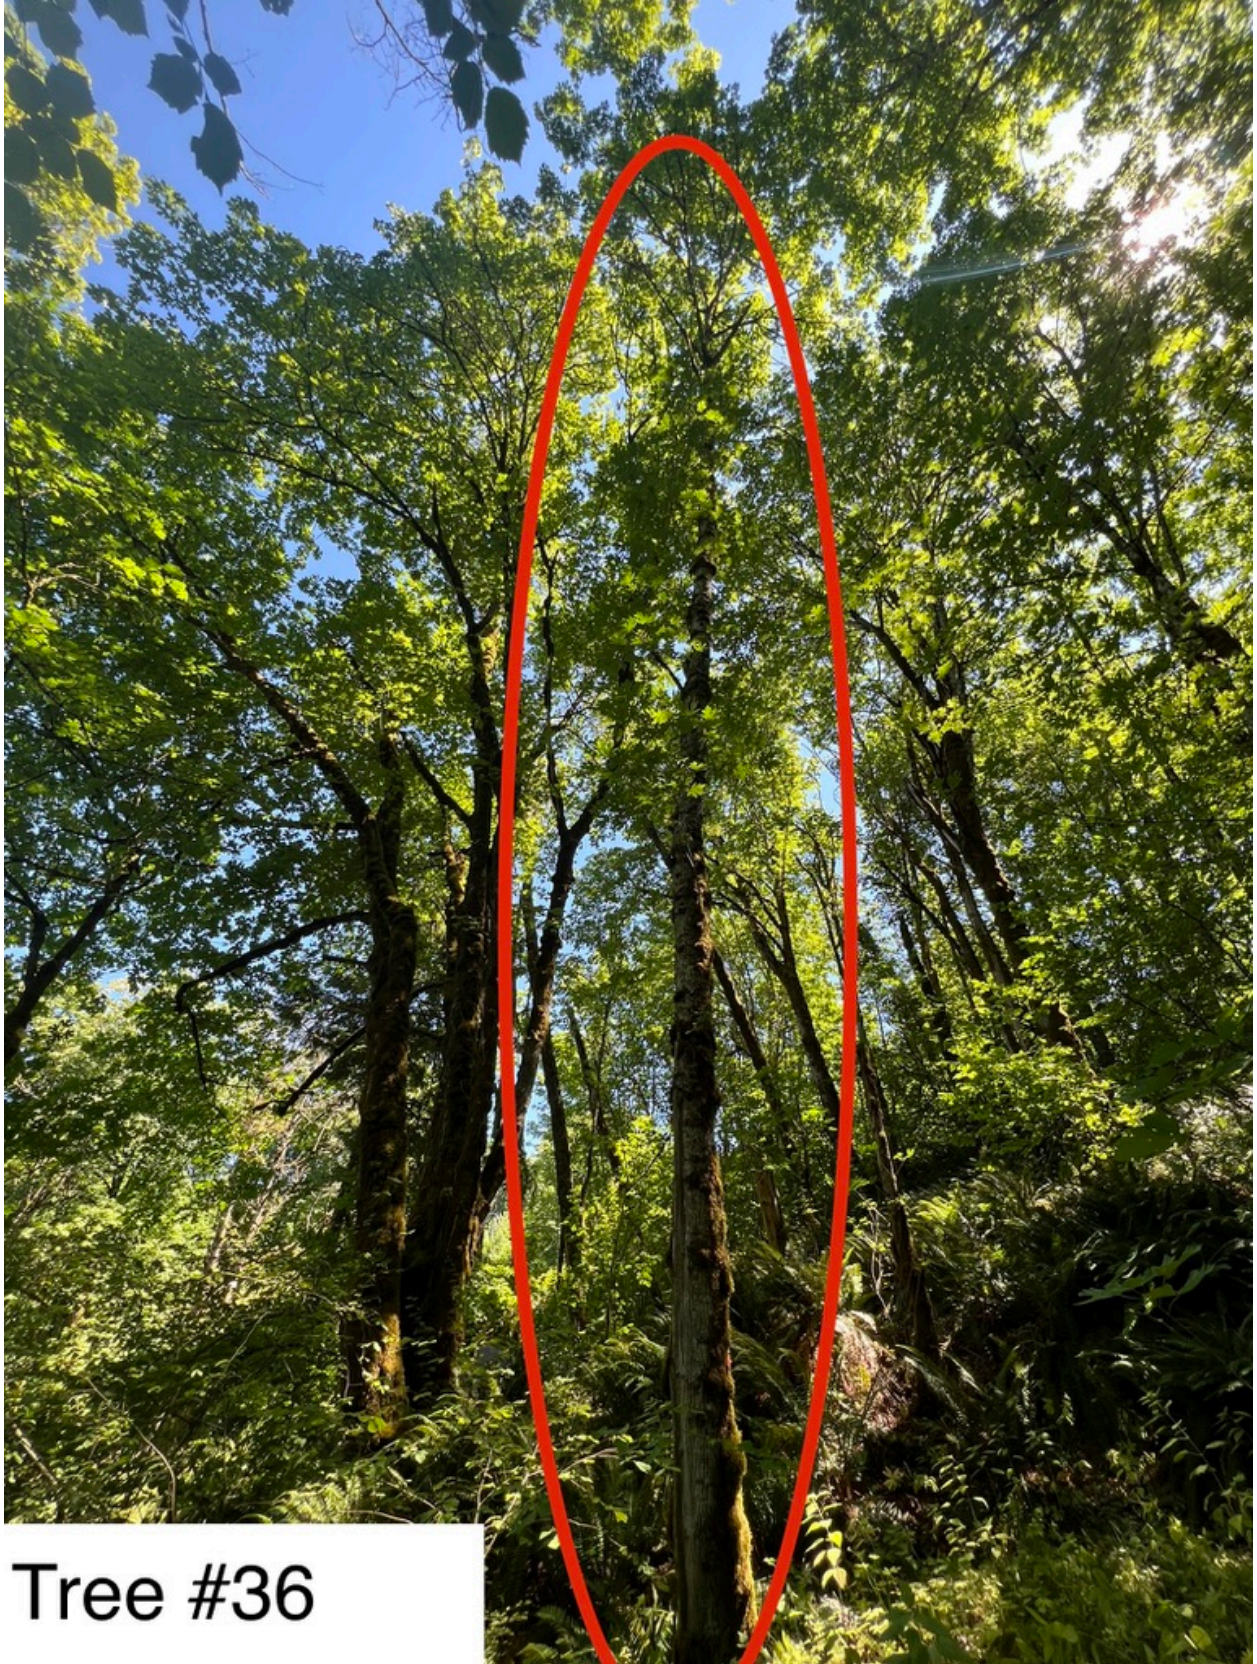
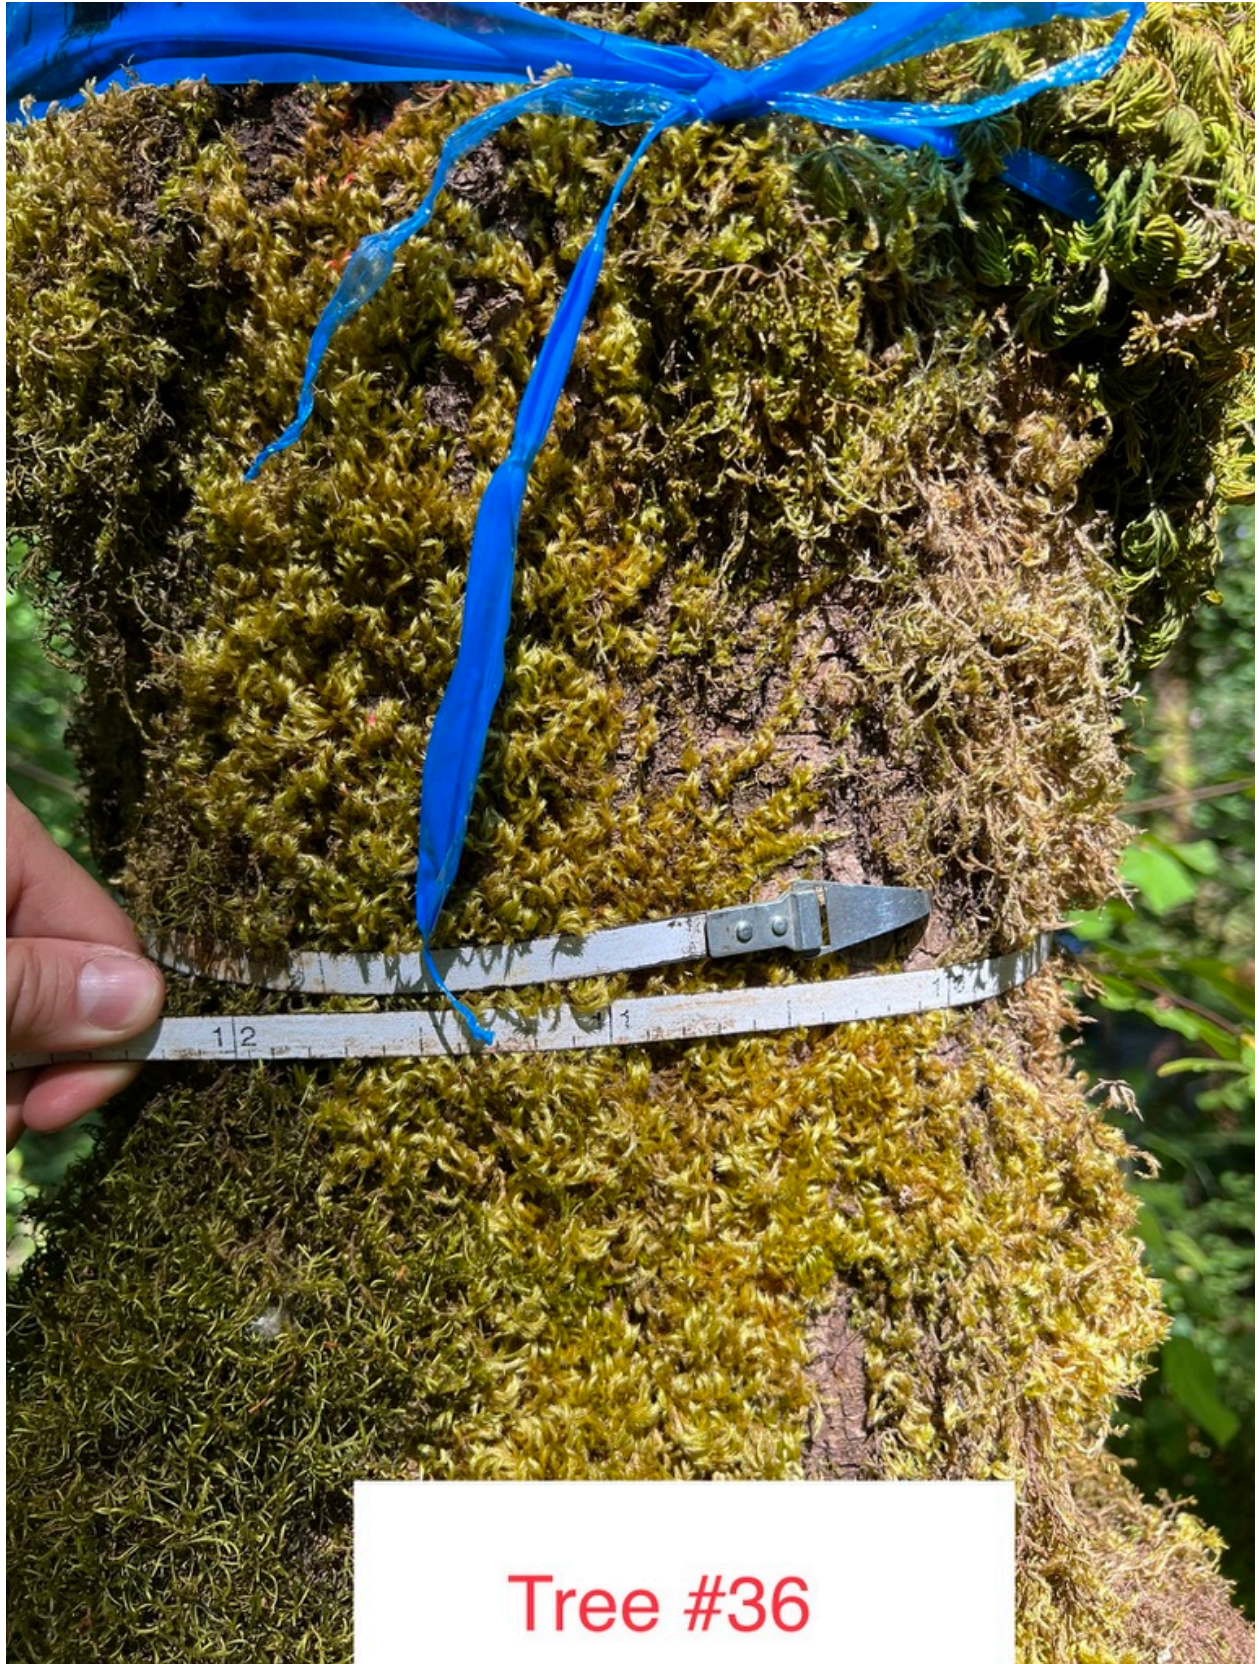
Tree #36

Dead/Missing bark Abnormal bark texture/color
 Codominant stems Included bark Cracks
 Sapwood damage/decay Cankers/Galls/Burls Sap ooze
 Lightning damage Heartwood decay Conks/Mushrooms
 Cavity/Nest hole % circ. Depth Poor taper
 Lean ° Corrected? NA
 Response growth NA
 Condition(s) of concern poor taper leads to wind throw
 Part Size 12" Fall Distance 45'

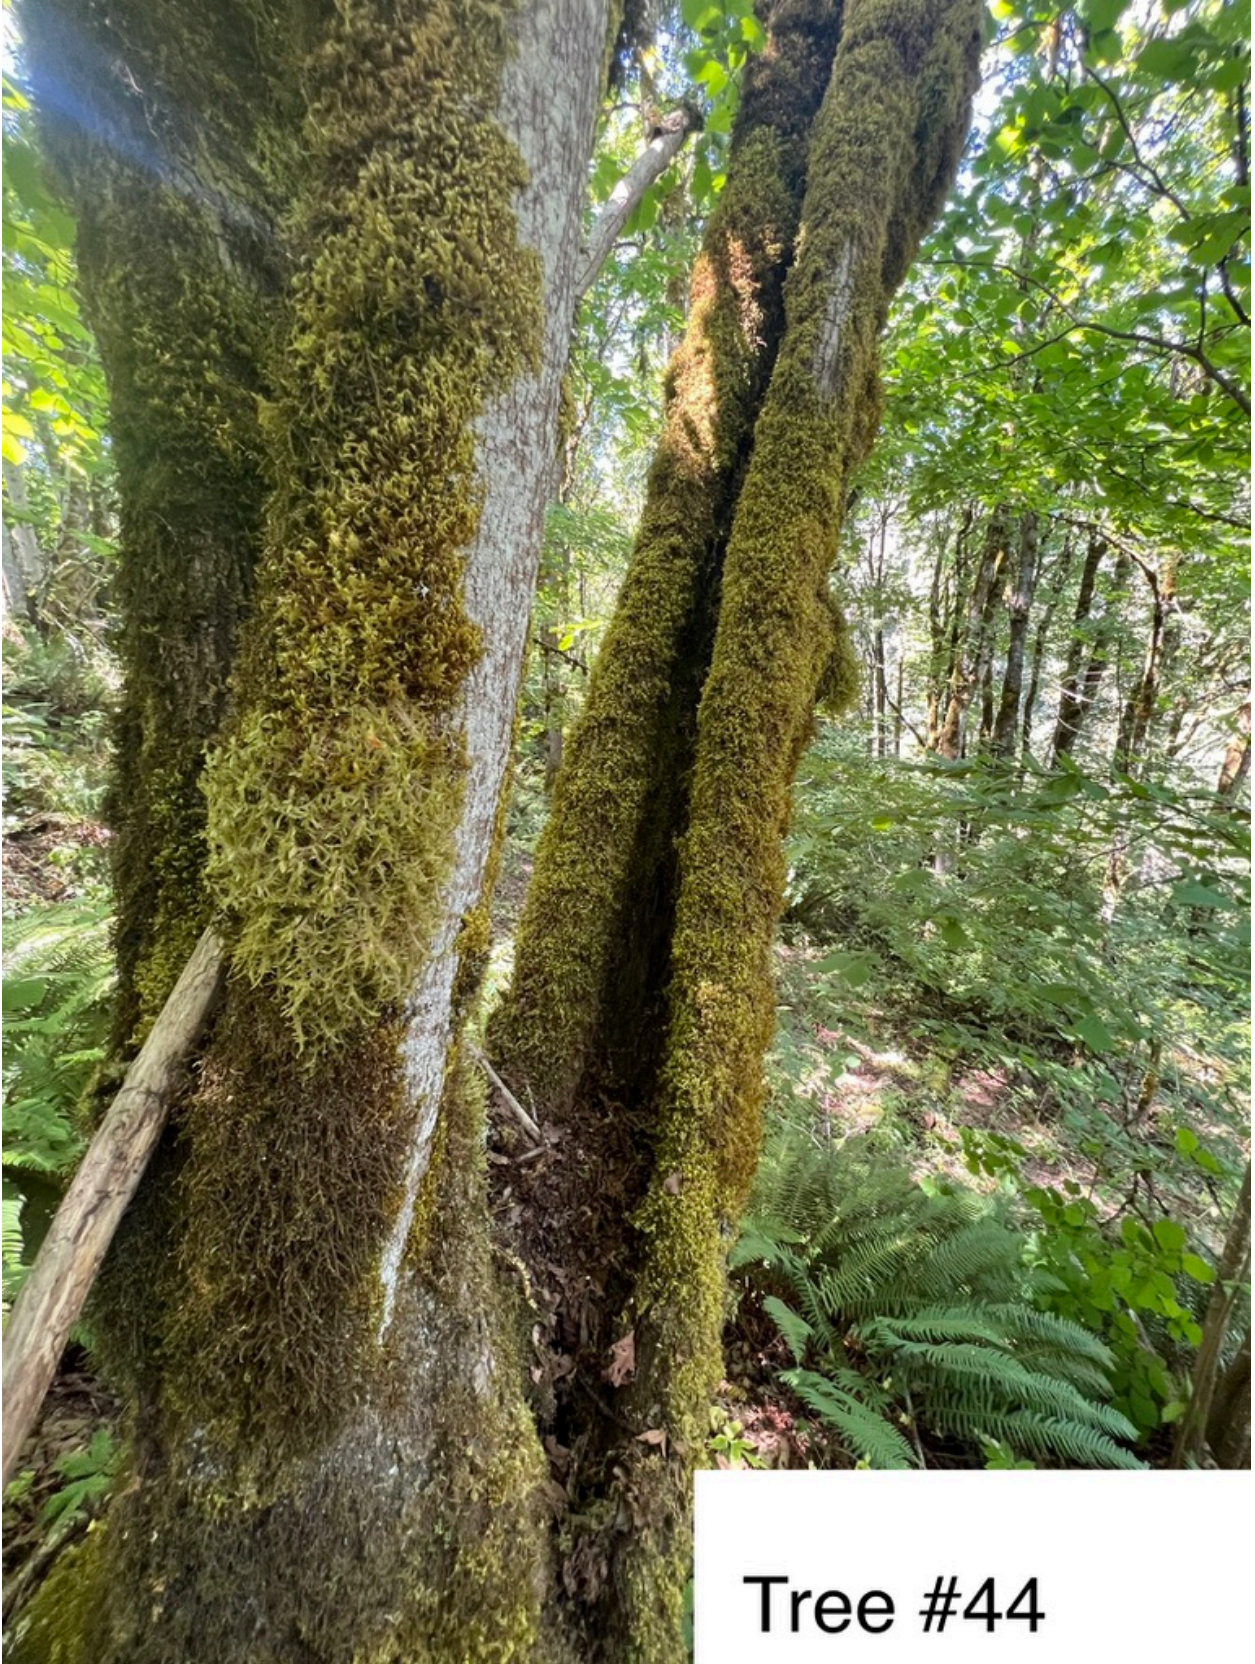
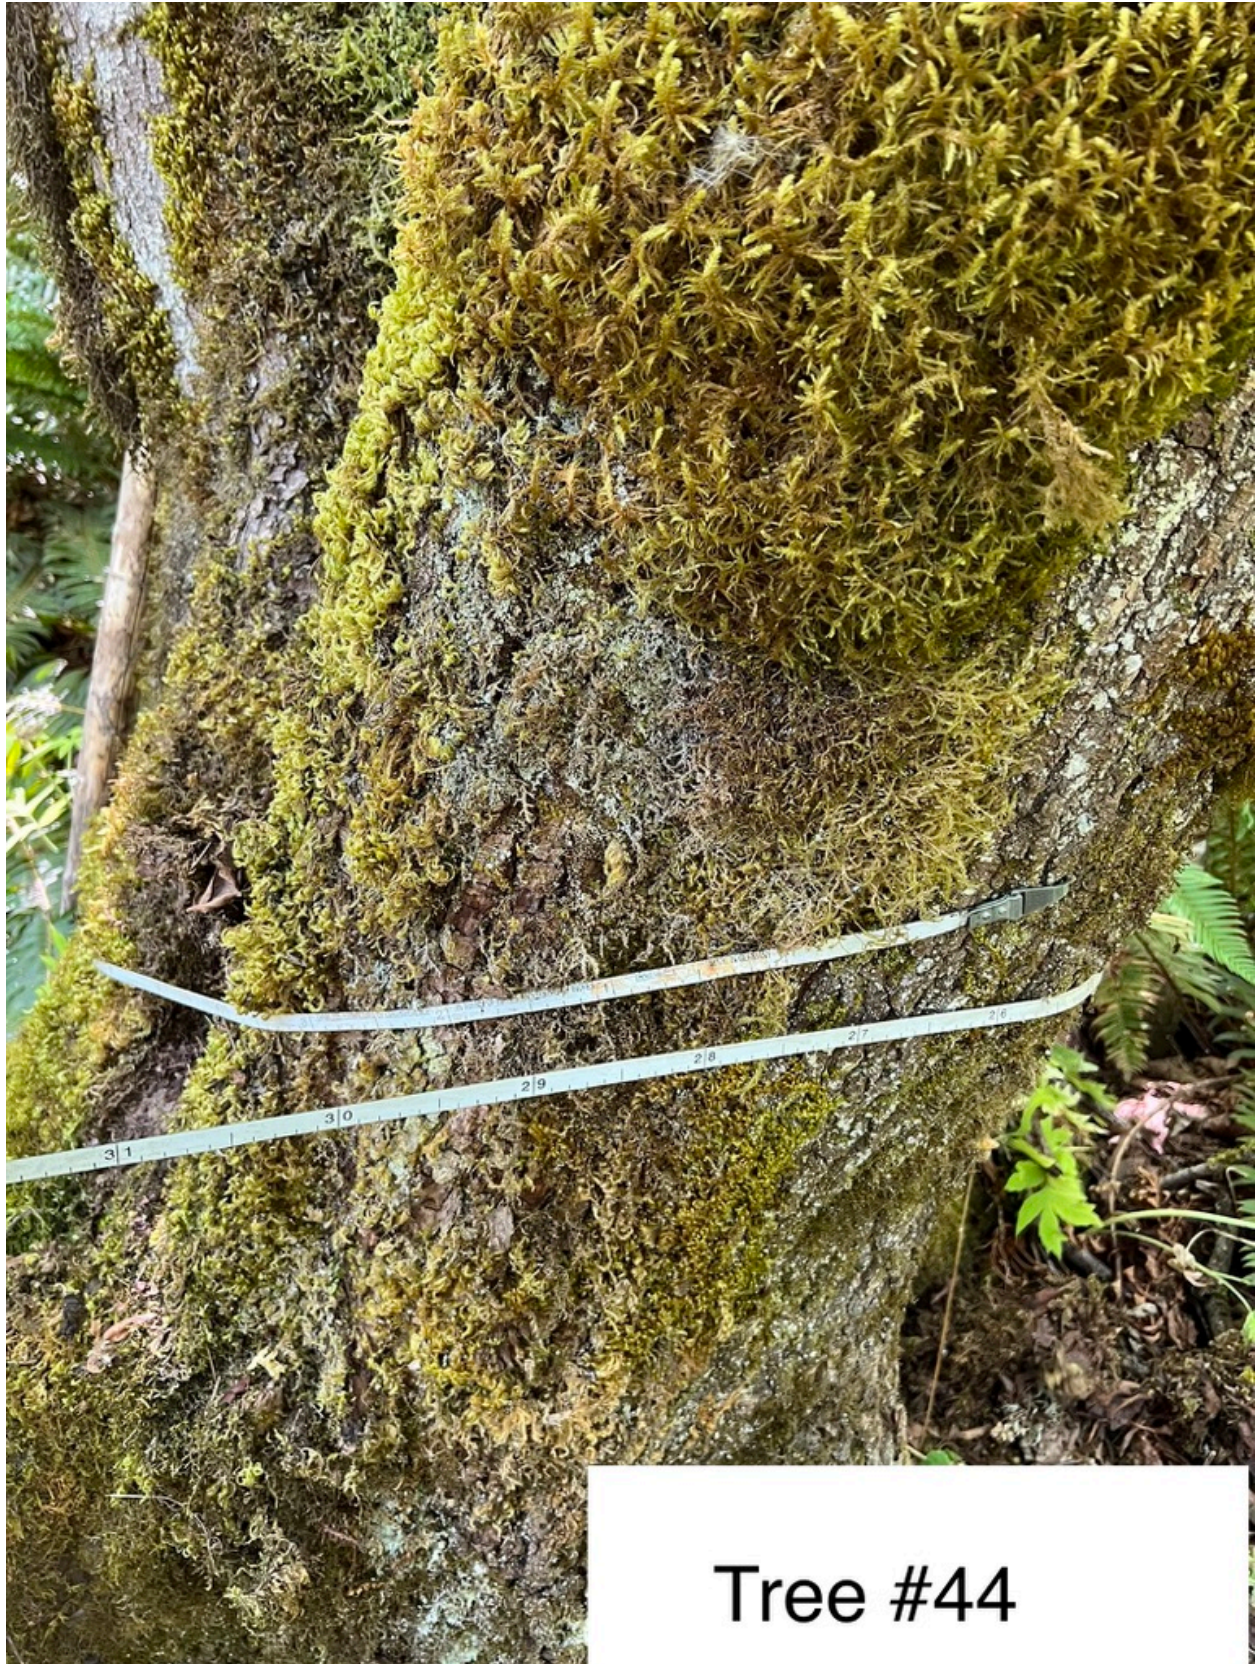
Tree #44

Dead/Missing bark Abnormal bark texture/color
 Codominant stems Included bark Cracks
 Sapwood damage/decay Cankers/Galls/Burls Sap ooze
 Lightning damage Heartwood decay Conks/Mushrooms
 Cavity/Nest hole 5 % circ. Depth 10" Poor taper
 Lean 26° Corrected? no
 Response growth NA
 Condition(s) of concern split/cracked trunk w/ canes
 Part Size 16" Fall Distance 60"
